The Zagreb (Croatia) M5.5 Earthquake on 22 March 2020

Source / Izvornik: **Geosciences, 2020, 10, - - -**

Journal article, Published version

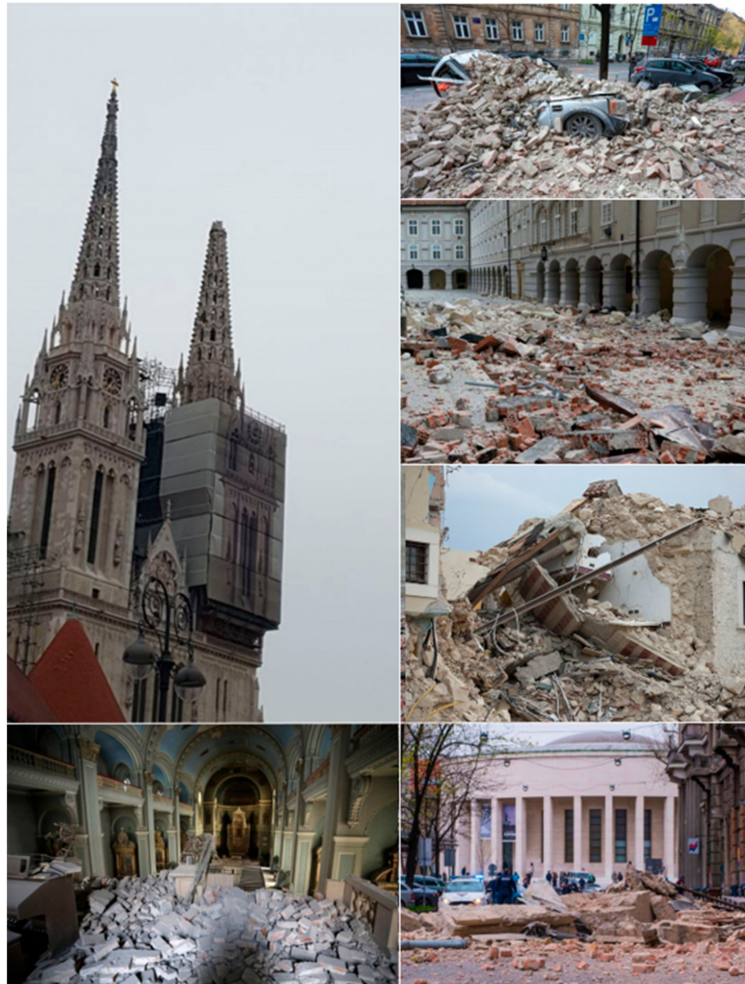
Figure 6. Photos of damage in Zagreb caused by the 22 March 2020 earthquake.

The earthquake hit the city center hardest, and the initial information indicated that the damage was great. Much damage to the cultural and historical architectural heritage of the city of Zagreb was reported, with severe damage to the south tower of Zagreb Cathedral. About 16,555 residential, public and monumental buildings were damaged (Figure 6) as declared by [21,22].

Figure 6 illustrates that in the old city center, three- to five-story masonry buildings, constructed from the time period of the Austro-Hungarian monarchy to 1920, sustained very heavy damage or were destroyed due to the M5.5 Zagreb earthquake on 22 March 2020. There were 26,197 damaged buildings in total (approximately 1900 uninhabitable), among which 9642 were family houses (as declared by [21,22]). As stated in the Disaster Risk Assessment for the Republic of Croatia [24], before 1920, masonry buildings used wooden slab construction, while reinforced concrete (RC) slabs were introduced in the period from 1920 to 1945. Before 1945, buildings possessed only initial earthquake resistance, and earthquake load was not considered in design (up to 5% of relevant peak ground acceleration-PGA was considered in design due to wind load). In compliance with Earthquake Hazard Map of Republic of Croatia [25], the relevant PGA based on 10% exceedance in 50 years, i.e., a return period of 475 years in the Zagreb area goes up to 0.28 g. The consideration of earthquake action in the design of buildings dates from 1946; however, the designs provided inadequate solutions. From 1945 to 1964, earthquake load was considered in the design of buildings by using simplified methodologies (the horizontal force at the top of the building); however, only up to 10% of the relevant PGA was considered in design. In 1964, as a result of the M6.9 Skopje (North Macedonia) earthquake in 1963, the Ordinance on Temporary Technical Regulations for Construction in Seismic Areas (Federal Republic of Yugoslavia (FRY) Official Journal, [26]) was issued. The ordinance required the construction of vertical or horizontal confining elements in masonry buildings, but it provided low earthquake resistance in general. In 1981, it was replaced by the Ordinance on Technical Standards for the Construction of High-Rise Buildings in Seismic Areas (FRY Official Journal, [27]), which provided moderate resistance. Between the years 1964 and 1998, 30–50% of the relevant PGA was considered in the building earthquake resistance design, and 70–100% was considered between 1998 and 2013. The aforementioned regulations were completely replaced by the contemporary standard EN 1998-1 [28] in 2013, which ensured high earthquake resistance (i.e., the earthquake load considered equals 100% of the relevant PGA).
