Multi-Level Sensing Technologies in Landslide Research—Hrvatska Kostajnica Case Study, Croatia

Abstract: In March 2018, a landslide in Hrvatska Kostajnica completely destroyed multiple households. The damage was extensive, and lives were endangered. The question remains: Can it happen again? To enhance the knowledge and understanding of the soil and rock behaviour before, during, and after this geo-hazard event, multi-level sensing technologies in landslide research were applied. Day after the event field mapping and unmanned aerial vehicle (UAV) data were collected with the inspection of available orthophoto and “geo” data. For the landslide, a new geological column was developed with mineralogical and geochemical analyses. The application of differential interferometric synthetic aperture radar (DInSAR) for detecting ground surface displacement was undertaken in order to determine pre-failure behaviour and to give indications about post-failure deformations. In 2020, electrical resistivity tomography (ERT) in the landslide body was undertaken to determine the depth of the landslide surface, and in 2021 ERT measurements in the vicinity of the landslide area were performed to obta

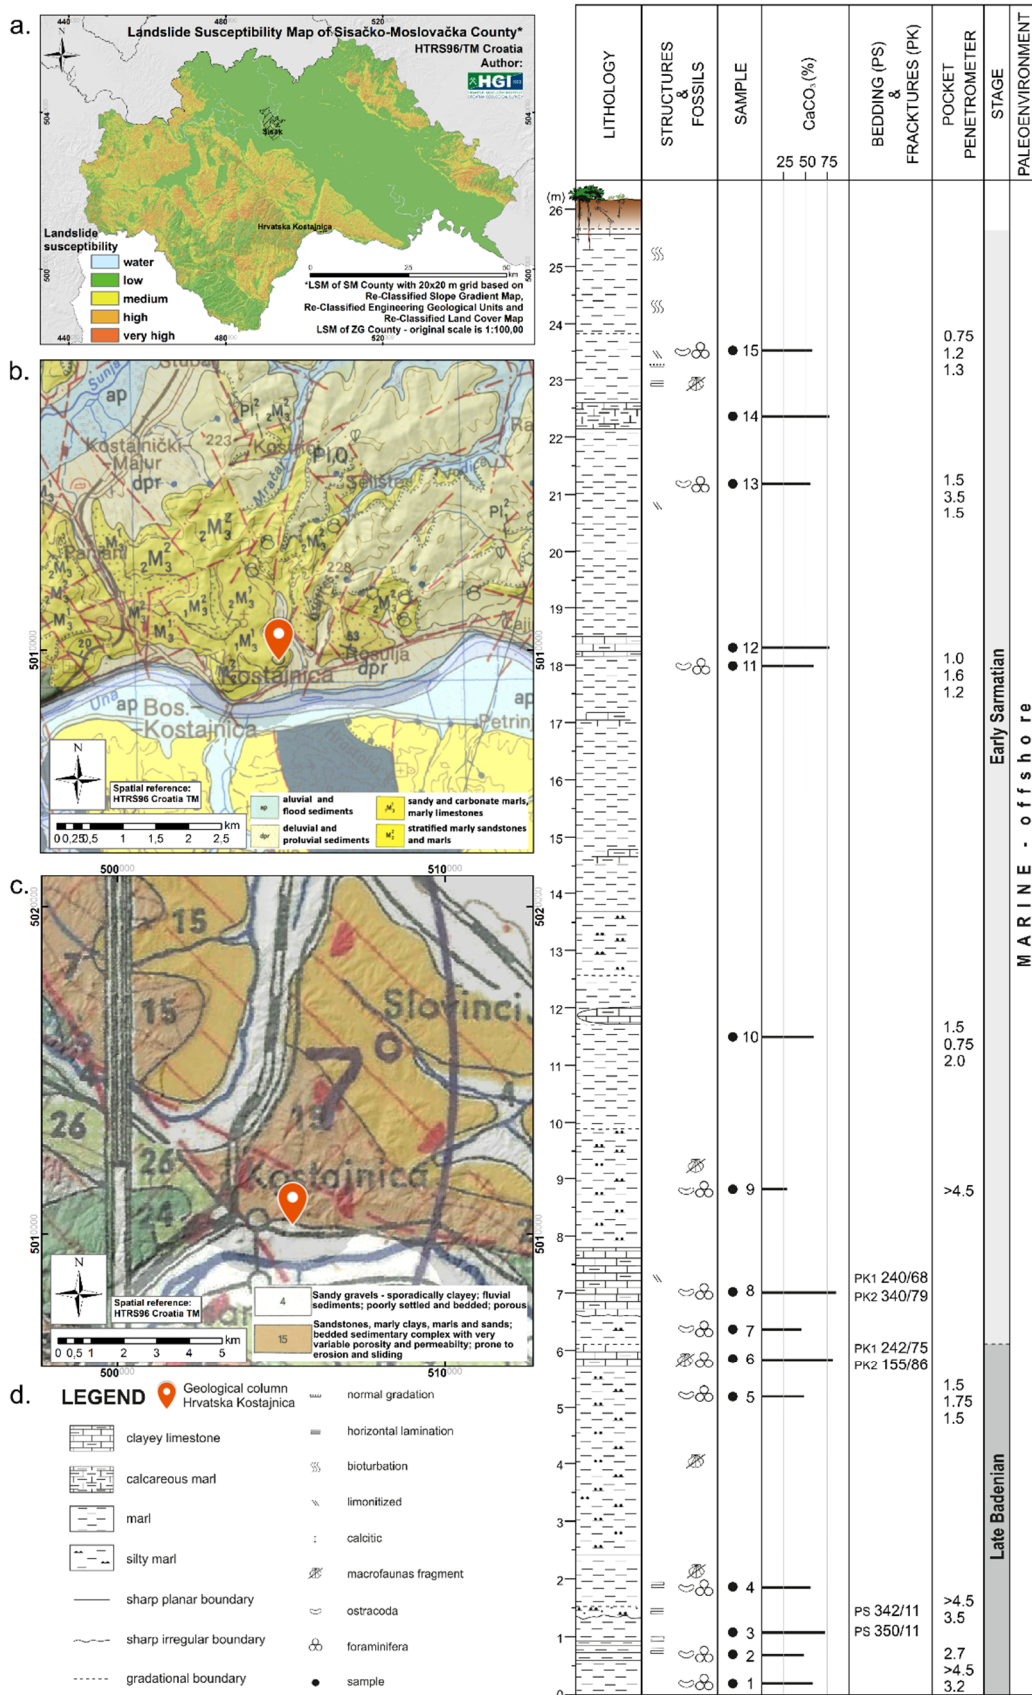
Figure 4. Study area “zoom in”: (a) landslide susceptibility Map of Sisačko-Moslavina County [4]; (b) detail from the Basic geological map [23]; (c) detail from the Engineering Geological Map [28]; and (d) the developed detailed geological column for Hrvatska Kostajnica landslide, modified after [24].

Available geological and landslide data were reviewed, mostly in the forms of existing guides and maps (Table 1, Figure 4a–d). Hrvatska Kostajnica is in the continental part of Croatia, where soils are commonly developed on the surface of the different types of sediments and slides in soils frequently occur (Figure 4a) [4].

This is also reflected in the Re-Classified Lithological Map of Croatia, where clayey materials and alluvial/diluvial deposits are depicted in the study area [6]. The 1:100,000 scale Basic geological map (Figure 4b) [23] and the 1:100,000 scale Geological Map of Sisačko-Moslavina County [29] indicate that Badenian (conglomerates, sandstones, marls, limestones) and Sarmatian (sandstones, gravels, sands, marls) deposits are present in the area with diluvial and proluvial Holocene sediments (sands, silts). Near the Una River, alluvial Holocene sediments (sands, gravels, silts, clays) are common [24]. In the 1:100,000 scale basic geological map, the presumptive fault locations are also marked (red dashed lines, Figure 4b) [23].

On the Landslide Susceptibility Map of Croatia, the wider area is generally depicted as prone to landslides [27], as on the 1:100,000 scale Landslide Susceptibility Map of Sisačko-Moslavina County (Figure 4a) [4] and on the 1:500,000 scale Engineering Geological Map of Yugoslavia, on which active landslide locations are marked with red semi circles (Figure 4c) [28]. The detail from the 1:500,000 scale Engineering Geological Map indicates that two units are present in the study area: (i) sandstones, marly clays, marls, and sands; Upper Neogene lacustrine bedded sedimentary complex with very variable porosity and permeability, prone to erosion and sliding (brown on map); and (ii) sandy gravels, sporadically clayey; Pleistocene–Holocene fluvial sediments, mostly covered with loam, poorly settled and bedded, rather porous (white on map). The topographic maps (1:5000 from NGA and the one developed from LIDAR data) in combination with developed landslide inventory for study area provides a good idea about the spatial distribution of landslides in this area (shown in detail in Figure 2d).

From the available geological and landslide data, it can be concluded that the area is generally prone to landslides (see Section 2.3. and Figure 4) [27,28]. The developed 26 m high detailed geological column at main scarp of Hrvatska Kostajnica landslide reveals that the landslide occurred mainly in the “marly” sediments, but clayey (weathered) limestone is also present at location [24]. The landslide affected the soil layer, weathered zone, and “bedrock”, but no clear sliding zone(s) was mapped on the field during geological column development and during engineering geological mapping in 2018 [25]. The assumption is that there were multiple weakened “zones” due to rhythmic changes within material, i.e., geological heterogeneity. Multiple field measurements and samples from the landslide head scarp were taken for the determination of on-site material characteristics and laboratory analysis. Field pocket penetrometer values and CaCO_3 ratio variations also indicate differences in material properties (Figure 4d). Within weathered clayey limestones on bedding plains and fracture planes, “preferred” seepage and water “leakage” could

have occurred, and at the same time in these discontinuities thin clay layer(s) are sometimes present. Moreover, seven interchanges of marls–clayey limestone can be tracked at geological column/landslide main scarp (Figure 4). On this geological column, the main geo-specific characteristics of the location can be observed: the material is mainly marl with silts and it is interlayered with clayey limestone. This “interlayering” is common, and the materials are generally weathered. Moreover, the bulk analysis of marls shows that the main mineral components are calcite and clay minerals (i.e., smectite, illite, kaolinite, vermiculite), with some of them with high shrink-swell capacity [24]. All the “geo” data indicate multiple sliding surfaces as result of “rhythmic” changes within the material.

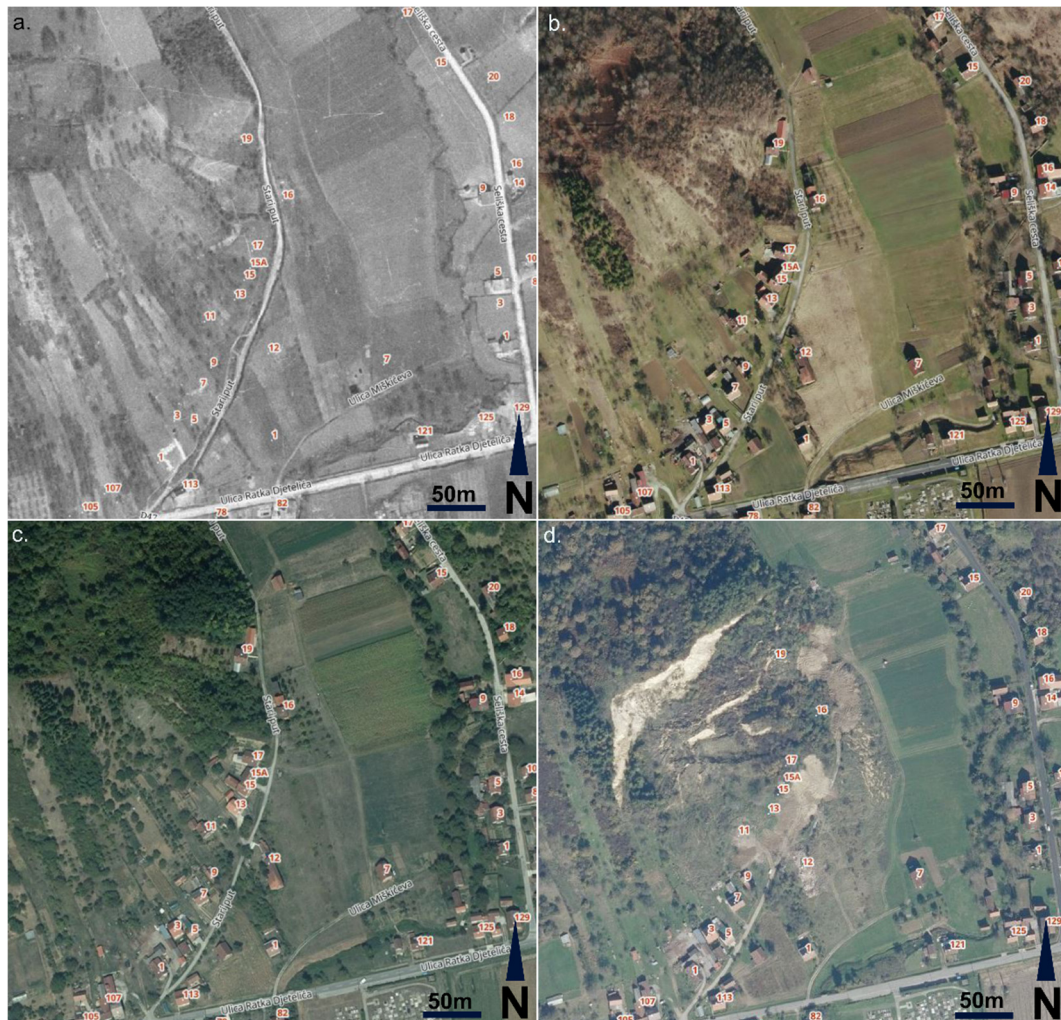
Figure 5. Hrvatska Kostajnica landslide area orthophotos from National Geodetic Administration of Croatia (NGA): (a) from 1968—historical data; (b) from 2016—pre-failure data; (c) from 2018—(recent) pre-failure data; and (d) from 2020—post-failure data.

Available orthophotos were reviewed as a source of land use change records (Figure 6a–d) [12,32]. In the historical photo from 1968, the landslide area is cropland without houses/objects (Figure 5a). On the “recent” photos from 2016 (Figure 5b) and 2018 (Figure 5c), the pre-failure situation can be observed: houses (1–19 house numbers), croplands, and woods. On the post-failure photo from 2020 (Figure 5d), it is visible that

houses 11–19 are removed (as they were destroyed or heavily damaged by landslide) and the croplands are destroyed. Houses 7 and 9 are damaged while houses 1, 3, and 5 are still endangered. In all figures (Figure 5a–d), the house numbers at Stari put Street are marked as reference. Stari put Street was completely destroyed by the landslide (Figure 5d).

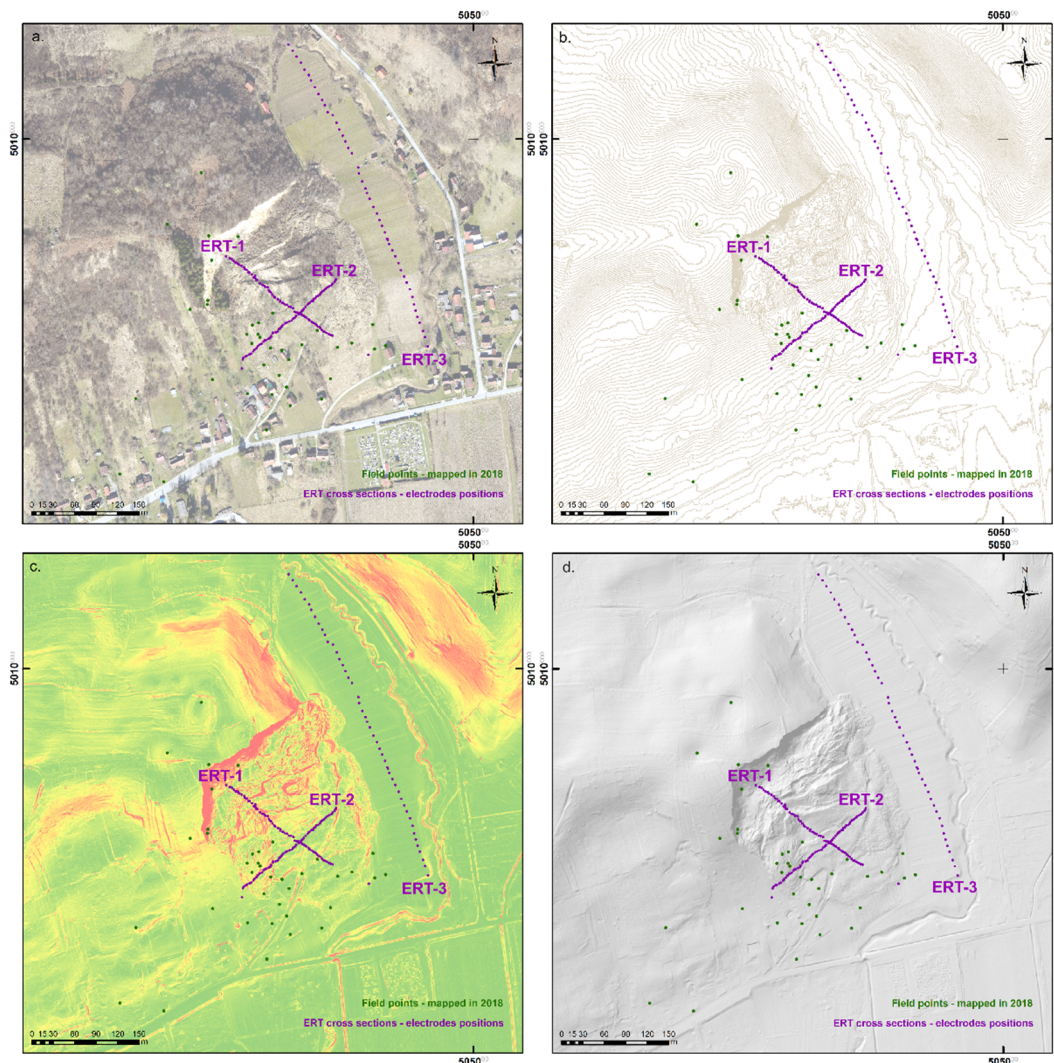
Figure 7. High resolution data from the Hrvatska Kostajnica area and landslide study area with mapped field points from 2018 and locations of ERT cross sections from 2020 and 2021: (a) detailed orthophoto from 2021; (b) 1 m contour lines based topography map; (c) detailed slope model; and (d) detailed terrain hillshade model.

Based on aerial LIDAR scanning, high resolution remote sensing data sets (Figure 7a–d) were used in landslide model development [6,43–45]. With the combination of a detailed orthophoto (Figure 7a), 1 m contour lines developed from LIDAR data (Figure 7b), a detailed slope model (Figure 7c), and terrain hillshade model (Figure 7d), quality terrain landslide surface model development (2D) was possible (Figure 8) [12,46]. These high

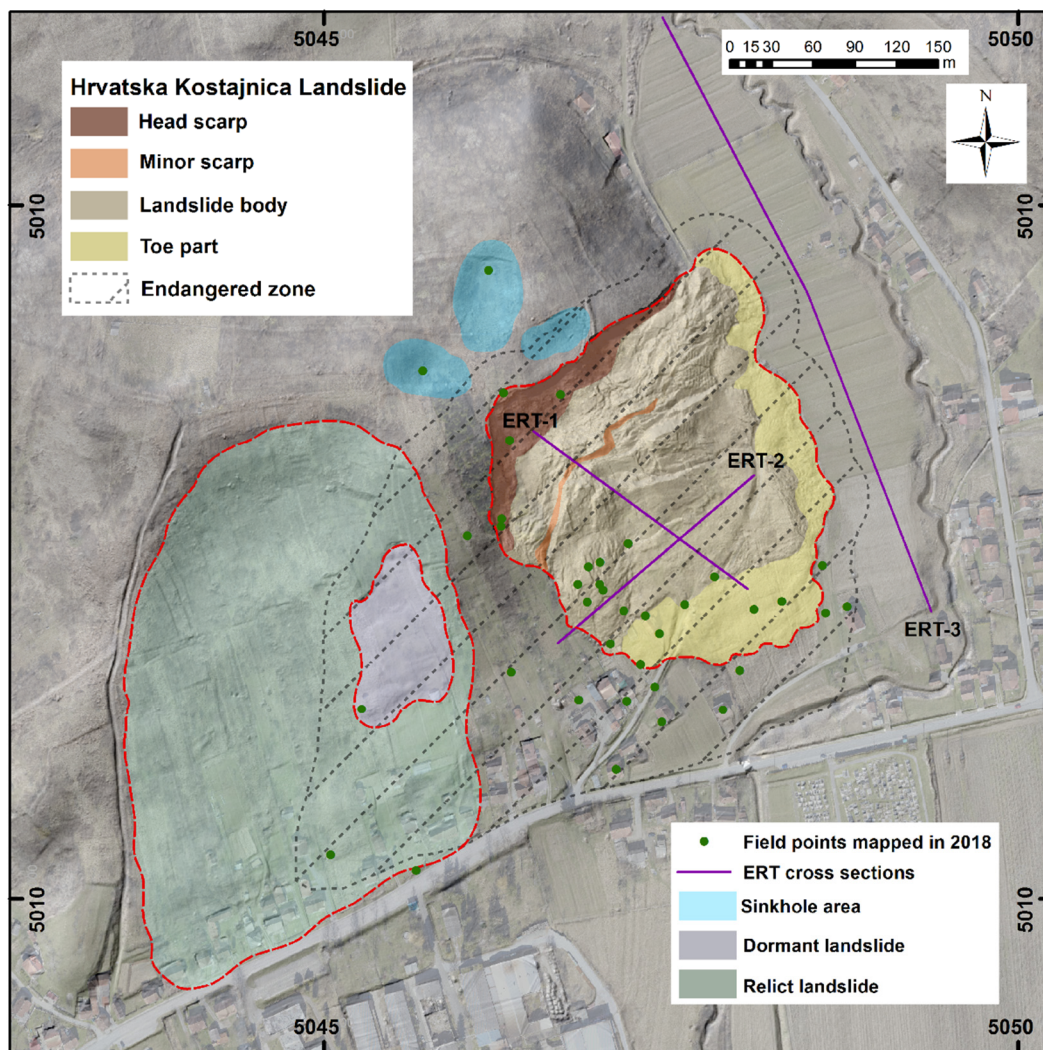
Figure 8. New Hrvatska Kostajnica Landslide Map with marked areas of active, dormant and relict landslide. Landslide areas are depicted with red dashed lines. On the map re-defined area of landslide(s) endangered zone is also marked (grey dashed polygon area).

Using detailed LIDAR based data, precise terrain landslide surface model development was possible, which served as baseline for new landslide map development [47]. A precise terrain landslide surface model was also used for landslide features re-evaluation and mapping and the re-evaluation of possible endangered zones. As a result, the New Hrvatska Kostajnica Landslide Map was developed (Figure 8). The map was also field verified in September 2021 (within GeoTwinn project, with experts from the Geological Survey of Denmark and Greenland, GEUS).

On the New Hrvatska Kostajnica Landslide Map, all the areas which are/or could be influenced by landslide(s) are reviewed and as a result the area of Endangered zone is redefined [43,45,46]. Within the Hrvatska Kostajnica landslide body, there is still activity: the erosion of the head scarp area due to atmospheric influences is an ongoing process i.e., the landslide is developing retrogressively [6,44,47]. Moreover, the settlement of the colluvium at the toe part area is ongoing at some (minor) rate. In the landslide body, there are still many wide-open cracks which are not stabilized. In the case of extreme rain, new movements within landslide body are possible. That is the reason for the endangered zone encircling the area of the active landslide body (same as on field map and report from 2018), but after revision of the available data the endangered zone was enlarged and an area with no traces of deformations was included with the area of the dormant landslide. The reason

for that is the following: according to the data analysis, it became evident that to the east a relict landslide area exists (already partially mapped on the field in 2018), and within that landslide body a dormant landslide can also be distinguished (Figure 8). Between these landslides, a steep “terrain ramp” exists. It is approximately 75 m wide and 250 m long and without visible traces of deformation(s). However, it is reasonable to expect for this (in this moment stable) area to eventually become un-stable and that the existing objects downslope could be endangered in the future by movements, i.e., new landslide(s). The new “terrain ramp” landslide(s) could also reactivate the dormant landslide to the east. Therefore, for ~20 households, landslide risk still exists in some, not negligible, percentage. On the map three sinkhole areas in the vicinity of the landslide head scarp are also marked. Their “importance” is in the “channeling” of the surface waters (rain) into the landslide body and existing terrain ramp area. The positions of the ERT cross sections are also marked on the map: ERT-1 and ERT-2 in the landslide body and ERT-3 in the vicinity of the landslide
