Multi-Level Sensing Technologies in Landslide Research—Hrvatska Kostajnica Case Study, Croatia

Abstract: In March 2018, a landslide in Hrvatska Kostajnica completely destroyed multiple households. The damage was extensive, and lives were endangered. The question remains: Can it happen again? To enhance the knowledge and understanding of the soil and rock behaviour before, during, and after this geo-hazard event, multi-level sensing technologies in landslide research were applied. Day after the event field mapping and unmanned aerial vehicle (UAV) data were collected with the inspection of available orthophoto and “geo” data. For the landslide, a new geological column was developed with mineralogical and geochemical analyses. The application of differential interferometric synthetic aperture radar (DInSAR) for detecting ground surface displacement was undertaken in order to determine pre-failure behaviour and to give indications about post-failure deformations. In 2020, electrical resistivity tomography (ERT) in the landslide body was undertaken to determine the depth of the landslide surface, and in 2021 ERT measurements in the vicinity of the landslide area were performed to obta

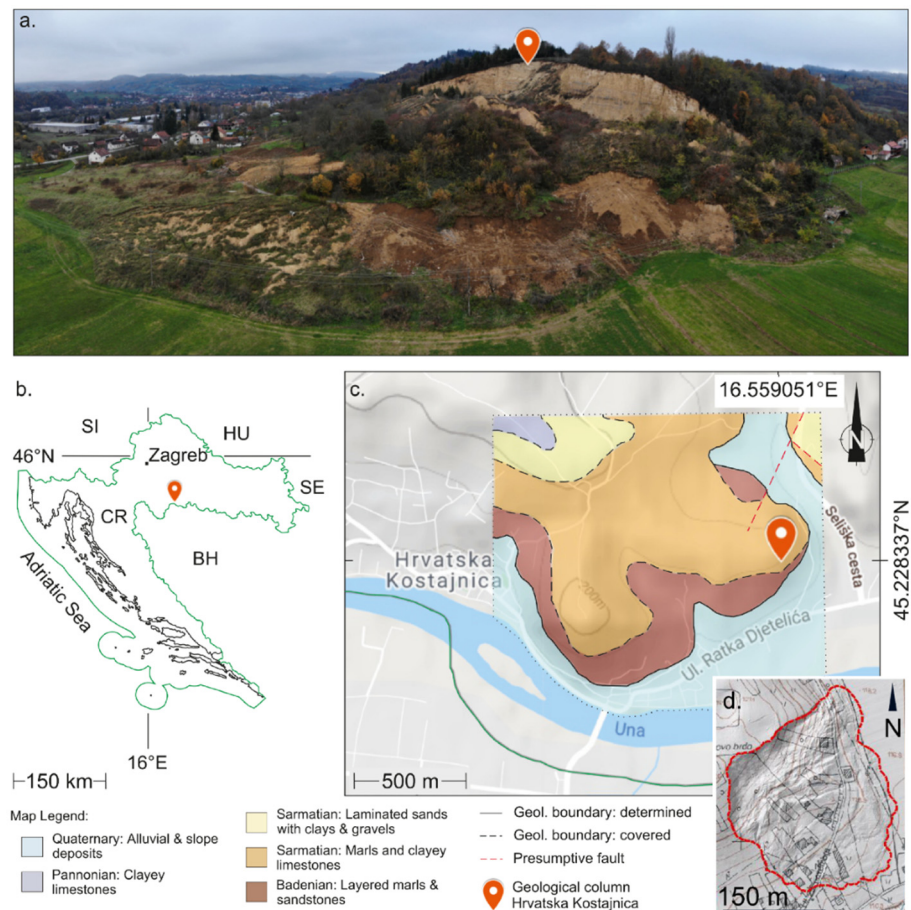
Figure 2. Study area: (a) landslide panorama in Hrvatska Kostajnica—on the south-eastern slope of Kubarnovo brdo, photo taken by unmanned aerial vehicle (UAV), by Croatian Geological Survey (CGS); (b) landslide location is in Croatia, near the border with Bosnia and Herzegovina; (c) basic geological data [23,24]; and (d) detail from topographic map (before landslide) overlaid with landslide area and detailed hillshade DEM (after landslide) and houses within landslide area: destroyed and damaged. Landslide area was defined by Croatian Geological Survey (CGS).

Geographically, the study area is located on the south-eastern slope of Kubarnovo brdo, a hilly area (Figure 2a). The landslide toe part is on the flat area near Kostjničica stream situated only 100 m east from the landslide, and ~400 m south is Una River. Geologically [23], within Quaternary alluvial and silty flood sediments slope deposits are also present. The landslide occurred in Sarmatian marls and clayey limestones and Badenian layered marls and sandstones (Figure 2c) [24]. In terms of engineering geology [25,26] there is soil on the surface in the area. The thickness of soil varies but it is generally thinner than 0.5 m. At the main scarp area, the soil layer thickness is between 0.3 and 0.7 m. Below the soil layer, there is a layer of diluvial sediments which are represented by clays and clayish marls up to 3 m thickness (estimated). These sediments are weathered, and the weathered zone can reach up to 5 m of depth (estimated). This zone of weathered bedrock is generally below the stretch of the diluvial sediments. These weathered materials are (mainly) composed of sandy–silty-clays. Below the weathered zone bedrock follows, which is represented by clayish marls, silty marls, as well as layers of sandstones and weathered clayish limestones. The landslide has affected the soil layer, weathered zone, and bedrock, so the material characteristics vary in a wide range from soils to rocks. The actual study area covers $\sim 500 \times 500$ m and it is somewhat wider than the landslide area.
