# Multi-Level Sensing Technologies in Landslide Research—Hrvatska Kostajnica Case Study, Croatia

Source / Izvornik: **Sensors**, 2021, 22

**Abstract:** In March 2018, a landslide in Hrvatska Kostajnica completely destroyed multiple households. The damage was extensive, and lives were endangered. The question remains: Can it happen again? To enhance the knowledge and understanding of the soil and rock behaviour before, during, and after this geo-hazard event, multi-level sensing technologies in landslide research were applied. Day after the event field mapping and unmanned aerial vehicle (UAV) data were collected with the inspection of available orthophoto and “geo” data. For the landslide, a new geological column was developed with mineralogical and geochemical analyses. The application of differential interferometric synthetic aperture radar (DInSAR) for detecting ground surface displacement was undertaken in order to determine pre-failure behaviour and to give indications about post-failure deformations. In 2020, electrical resistivity tomography (ERT) in the landslide body was undertaken to determine the depth of the landslide surface, and in 2021 ERT measurements in the vicin

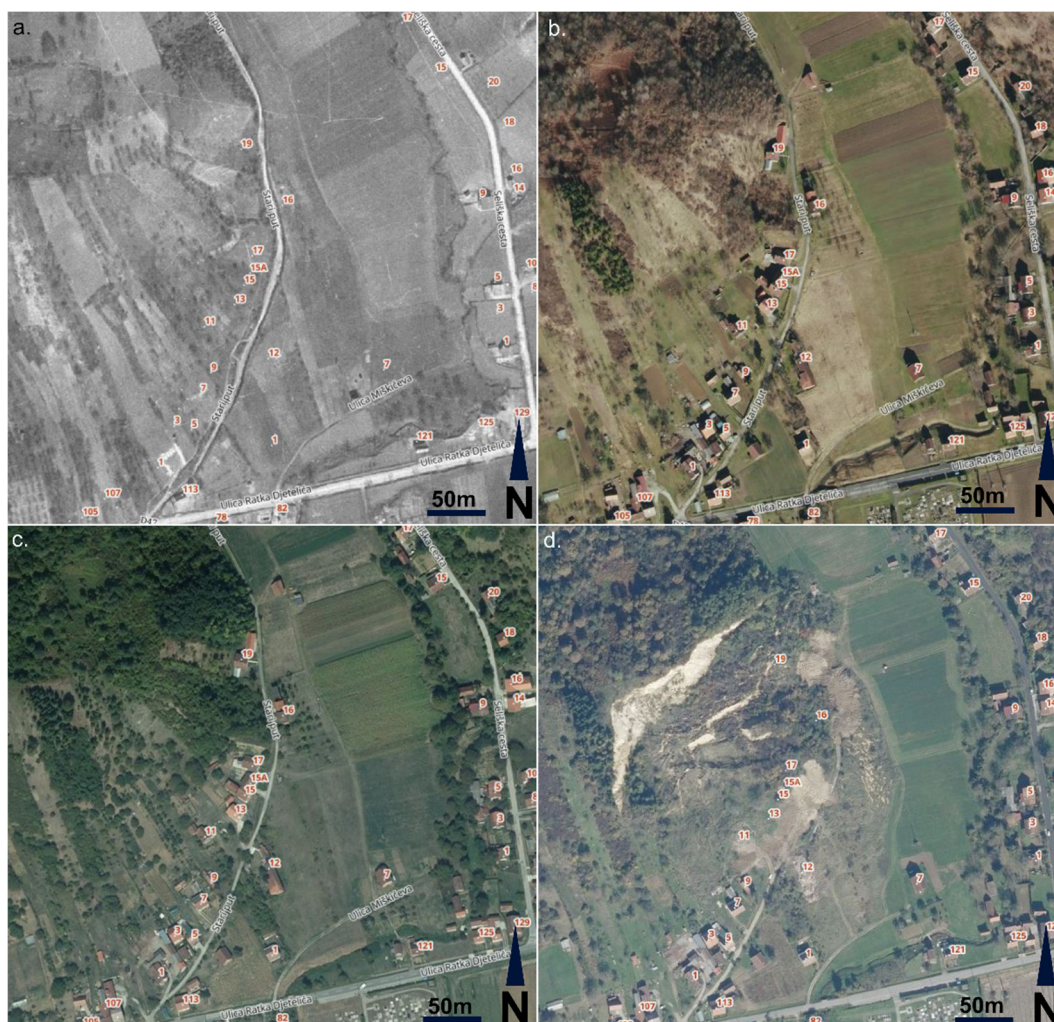
**Figure 5.** Hrvatska Kostajnica landslide area orthophotos from National Geodetic Administration of Croatia (NGA): (a) from 1968—historical data; (b) from 2016—pre-failure data; (c) from 2018—(recent) pre-failure data; and (d) from 2020—post-failure data.

Available orthophotos were reviewed as a source of land use change records (Figure 6a–d) [12,32]. In the historical photo from 1968, the landslide area is cropland without houses/objects (Figure 5a). On the “recent” photos from 2016 (Figure 5b) and 2018 (Figure 5c), the pre-failure situation can be observed: houses (1–19 house numbers), croplands, and woods. On the post-failure photo from 2020 (Figure 5d), it is visible that

houses 11–19 are removed (as they were destroyed or heavily damaged by landslide) and the croplands are destroyed. Houses 7 and 9 are damaged while houses 1, 3, and 5 are still endangered. In all figures (Figure 5a–d), the house numbers at Stari put Street are marked as reference. Stari put Street was completely destroyed by the landslide (Figure 5d).
