The Zagreb (Croatia) M5.5 Earthquake on 22 March 2020

Article

Abstract: On 22 March 2020, Zagreb was struck by an M5.5 earthquake that had been expected for more than 100 years and revealed all the failures in the construction of residential buildings in the Croatian capital, especially those built in the first half of the 20th century. Because of that, extensive seismological, geological, geodetic and structural engineering surveys were conducted immediately after the main shock. This study provides descriptions of damage, specifying the building performances and their correlation with the local soil characteristics, i.e., seismic motion amplification. Co-seismic vertical ground displacement was estimated, and the most affected area is identified according to Sentinel-1 interferometric wide-swath data. Finally, preliminary 3D structural modeling of the earthquake sequence was performed, and two major faults were modeled using inverse distance weight (IDW) interpolation of the grouped hypocenters. The first-order assessment of seismic amplification (due to site conditions) in the Zagreb area for the M5.5 earthquake shows that ground motions of approximately 0.16–0.19 g were ampli

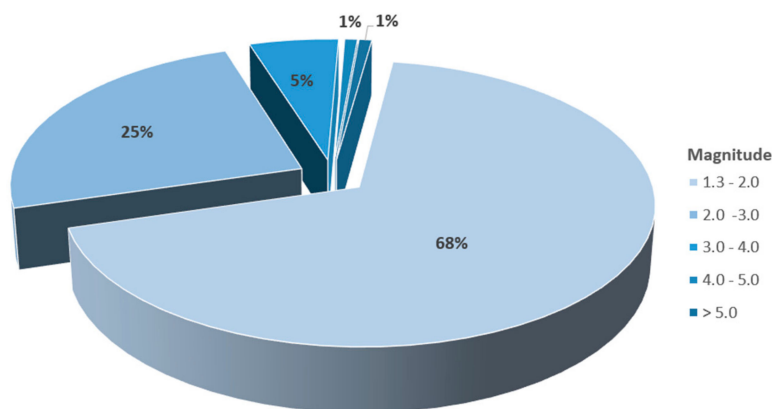
Figure 5. Percentage of earthquakes of each magnitude interval that occurred in the epicentral area of the Zagreb earthquake in the period from 22 March to 1 April 2020.

Since no one knows how much accumulated energy is released through a main earthquake, the aftershock activity is normal and not uncommon. Figure 5 presents the number of earthquakes of a certain magnitude (greater than 1.3) that occurred after the main earthquake of 22 March 2020 at 05:24 UTC.

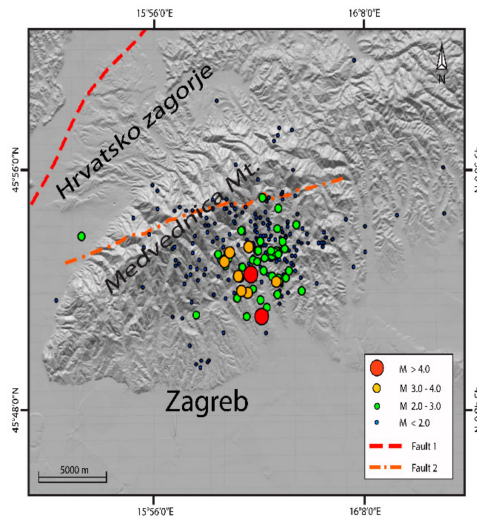
Figure 12. Spatial distribution of earthquake epicenter locations in the period from 22 March to 1 April 2020 (the Zagreb 2020 earthquake sequence). Fault lines are simple projections of the two modeled fault plains from the deep subsurface of the Medvednica Mountains to the surface (see Supplement 1 and Figure 13).

A set of 257 measurements was analyzed both spatially and temporally and processed for import into geological 3D modeling software. To achieve better visual insight, the hypocenters were scaled based on magnitude values (M_L) into four intervals: <2.0, 2.0–3.0, 3.0–4.0 and >4.0 (Figure 12).

A system of south-dipping longitudinal reverse faults has been mapped on the surface along the Medvednica Mountains [15] and interpreted in one of the latest tectonic models as the youngest (Pliocene to Quaternary) system of reverse faults ([11]; Figure 1) that are probably still active [7]. The reverse slip of the primary ruptured fault (Fault 1) of the Zagreb 2020 earthquake sequence (Figure 13; Supplement 1) generally corresponds to the frontal reverse fault striking along the northern foothills of the mountain (Figure 1b). However, the interpreted steep frontal reverse fault does not match the modeled gently inclined primary fault that is here interpreted as a thrust fault (Figure 13). Thus, a fault that could accommodate such a movement is probably a southeast-dipping thrust fault that completely dissects the basement of the central part of the Medvednica Mountains. This master thrust could represent a basal detachment (décollement) of the system of steeper reverse faults striking along the Medvednica Mountains. It could be steeper in the frontal part and thus could match the North Medvednica reverse fault, or it could be buried below the Neogene Hrvatsko Zagorje basin (Figure 1b; Figures 12 and 13).

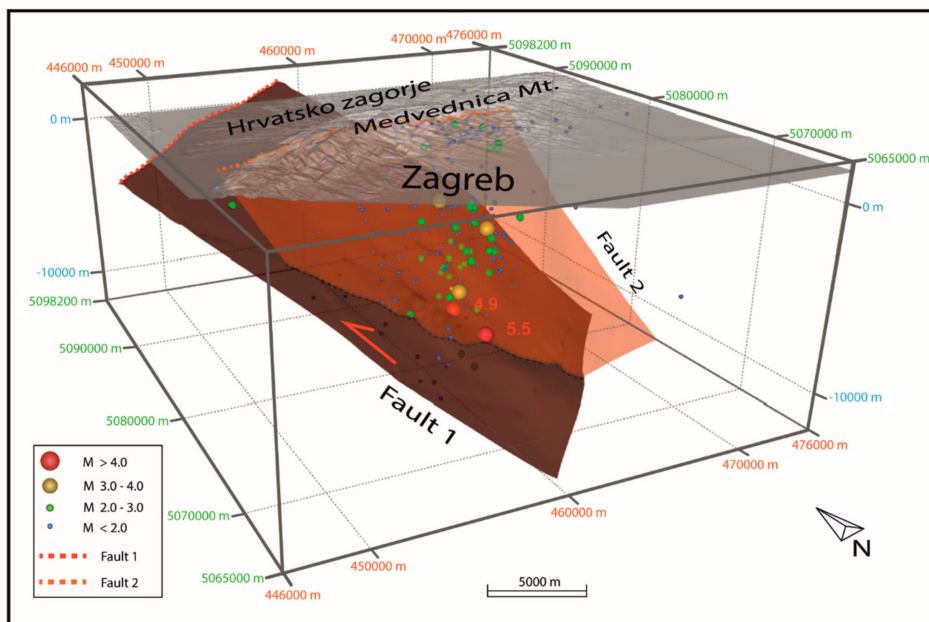
Figure 13. Preliminary structural 3D model of the Zagreb 2020 earthquake sequence. Coordinates are shown in HTRS96/TM coordinate system, and the elevation is in meters (no vertical exaggeration). Fault 1 is interpreted as a primary thrust fault, and Fault 2 is interpreted as a secondary (reverse?) fault.

Using the previously described methodology, a primary fault plane was modeled (Fault 1) based on the dataset containing 45 hypocenters, including most of the highest magnitude events in the Zagreb 2020 earthquake sequence. The fault is characterized by an orientation similar to the southeast-dipping instrumentally calculated fault-plane solutions of the main shock and the strongest aftershock (Figure 4). The rupture along Fault 1 propagated towards the northwest, apparently along a deep-rooted southeast-dipping thrust fault (125/31, dip direction/dip angle). The thrust fault can be projected to the surface where it virtually appears in the central part of the Hrvatsko Zagorje basin (Figures 1b and 13).
