The Zagreb (Croatia) M5.5 Earthquake on 22 March 2020

Journal article, Published version

Abstract: On 22 March 2020, Zagreb was struck by an M5.5 earthquake that had been expected for more than 100 years and revealed all the failures in the construction of residential buildings in the Croatian capital, especially those built in the first half of the 20th century. Because of that, extensive seismological, geological, geodetic and structural engineering surveys were conducted immediately after the main shock. This study provides descriptions of damage, specifying the building performances and their correlation with the local soil characteristics, i.e., seismic motion amplification. Co-seismic vertical ground displacement was estimated, and the most affected area is identified according to Sentinel-1 interferometric wide-swath data. Finally, preliminary 3D structural modeling of the earthquake sequence was performed, and two major faults were modeled using inverse distance weight (IDW) interpolation of the grouped hypocenters. The first-order assessment of seismic amplification (due to site conditions) in the Zagreb area for the M5.5 earthquake shows that ground motions of approxima

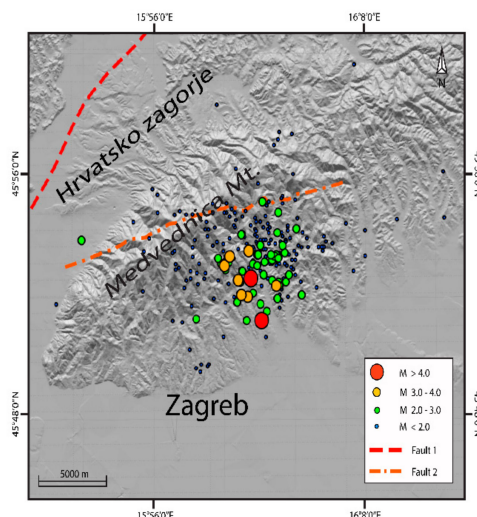
A set of 257 measurements was analyzed both spatially and temporally and processed for import into geological 3D modeling software. To achieve better visual insight, the hypocenters were scaled based on magnitude values (M_L) into four intervals: <2.0, 2.0–3.0, 3.0–4.0 and >4.0 (Figure 12).

Figure 12. Spatial distribution of earthquake epicenter locations in the period from 22 March to 1 April 2020 (the Zagreb 2020 earthquake sequence). Fault lines are simple projections of the two modeled fault plains from the deep subsurface of the Medvednica Mountains to the surface (see Supplement 1 and Figure 13).

A system of south-dipping longitudinal reverse faults has been mapped on the surface along the Medvednica Mountains [15] and interpreted in one of the latest tectonic models as the youngest (Pliocene to Quaternary) system of reverse faults ([11]; Figure 1) that are probably still active [7]. The reverse slip of the primary ruptured fault (Fault 1) of the Zagreb 2020 earthquake sequence (Figure 13; Supplement 1) generally corresponds to the frontal reverse fault striking along the northern foothills of the mountain (Figure 1b). However, the interpreted steep frontal reverse fault does not match the modeled gently inclined primary fault that is here interpreted as a thrust fault (Figure 13). Thus, a fault that could accommodate such a movement is probably a southeast-dipping thrust fault that completely dissects the basement of the central part of the Medvednica Mountains. This master thrust could represent a basal detachment (décollement) of the system of steeper reverse faults striking along the Medvednica Mountains. It could be steeper in the frontal part and thus could match the North Medvednica reverse fault, or it could be buried below the Neogene Hrvatsko Zagorje basin (Figure 1b; Figures 12 and 13).
