Journal article, Published version

The Zagreb (Croatia) M5.5 Earthquake on 22 March 2020

Keywords: Zagreb earthquake; Medvednica Mountains; seismicity; amplification; structural modeling; building damage

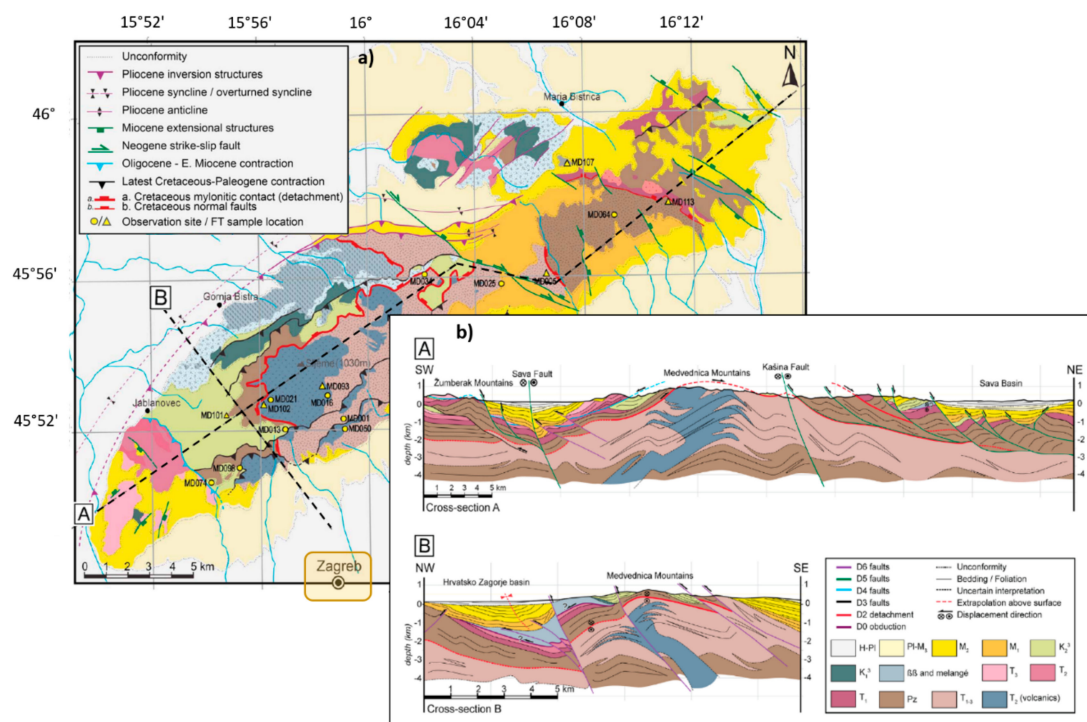
The Medvednica Mountains are composed of a Paleozoic to Mesozoic metamorphic core overlain by non-metamorphic Mesozoic and Cenozoic rocks ([13–15]; Figure 1a). All units are truncated by normal and reverse faults and are surrounded by the Miocene–Quaternary deposits of the Pannonian Basin.

Figure 1. (a) Geological map of the Medvednica Mountains. The map shows the location of the cross-sections A and B; (b) Cross-sections across the Medvednica Mountains: (A) longitudinal (SW–NE) and (B) transversal (NW–SE) (after [11]).

Using the previously described methodology, a primary fault plane was modeled (Fault 1) based on the dataset containing 45 hypocenters, including most of the highest magnitude events in the Zagreb 2020 earthquake sequence. The fault is characterized by an orientation similar to the southeast-dipping instrumentally calculated fault-plane solutions of the main shock and the strongest aftershock (Figure 4). The rupture along Fault 1 propagated towards the northwest, apparently along a deep-rooted southeast-dipping thrust fault (125/31, dip direction/dip angle). The thrust fault can be projected to the surface where it virtually appears in the central part of the Hrvatsko Zagorje basin (Figures 1b and 13).

A system of south-dipping longitudinal reverse faults has been mapped on the surface along the Medvednica Mountains [15] and interpreted in one of the latest tectonic models as the youngest (Pliocene to Quaternary) system of reverse faults ([11]; Figure 1) that are probably still active [7]. The reverse slip of the primary ruptured fault (Fault 1) of the Zagreb 2020 earthquake sequence (Figure 13; Supplement 1) generally corresponds to the frontal reverse fault striking along the northern foothills of the mountain (Figure 1b). However, the interpreted steep frontal reverse fault does not match the modeled gently inclined primary fault that is here interpreted as a thrust fault (Figure 13). Thus, a fault that could accommodate such a movement is probably a southeast-dipping thrust fault that completely dissects the basement of the central part of the Medvednica Mountains. This master thrust could represent a basal detachment (décollement) of the system of steeper reverse faults striking along the Medvednica Mountains. It could be steeper in the frontal part and thus could match the North Medvednica reverse fault, or it could be buried below the Neogene Hrvatsko Zagorje basin (Figure 1b; Figures 12 and 13).

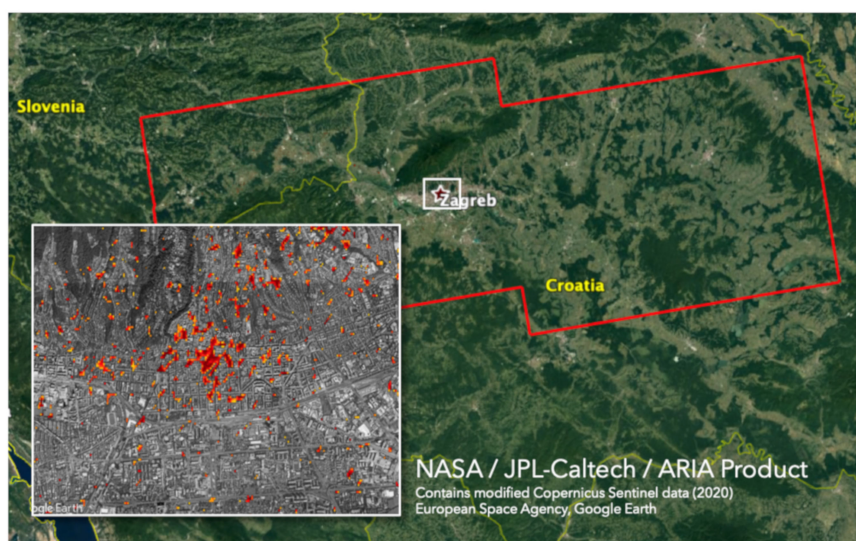
The extent of the damage is also visible on the damage proxy map (DPM) (Figure 7), which was created by the Advanced Rapid Imaging and Analysis (ARIA) team at NASA's Jet Propulsion Laboratory and the California Institute of Technology, both in Pasadena, California. The map depicts areas that were likely damaged. The map was derived from synthetic aperture radar (SAR) images from the Copernicus Sentinel-1 satellites, operated by the European Space Agency (ESA). The team compared a post-event image acquired on 23 March 2020 with pre-event images taken since January 2020. The image covers an area of 166 by 56 km (103 by 35 miles), shown by the large red polygon. Each pixel measures approximately 30 m across. The color variations from yellow to red indicate increasingly significant surface changes. Preliminary validation was performed by using photographs from various sources, including news media. This damage proxy map should be used as a guide to identify damaged areas. The full map is available online at [23].

Figure 7. Damage proxy map created by the Advanced Rapid Imaging and Analysis (ARIA) team at NASA's Jet Propulsion Laboratory (JPL) and the California Institute of Technology. This map contains modified Copernicus Sentinel data, processed by the ESA and analyzed by the NASA JPL/Caltech ARIA team. This task was carried out at the JPL, funded by NASA. [23].

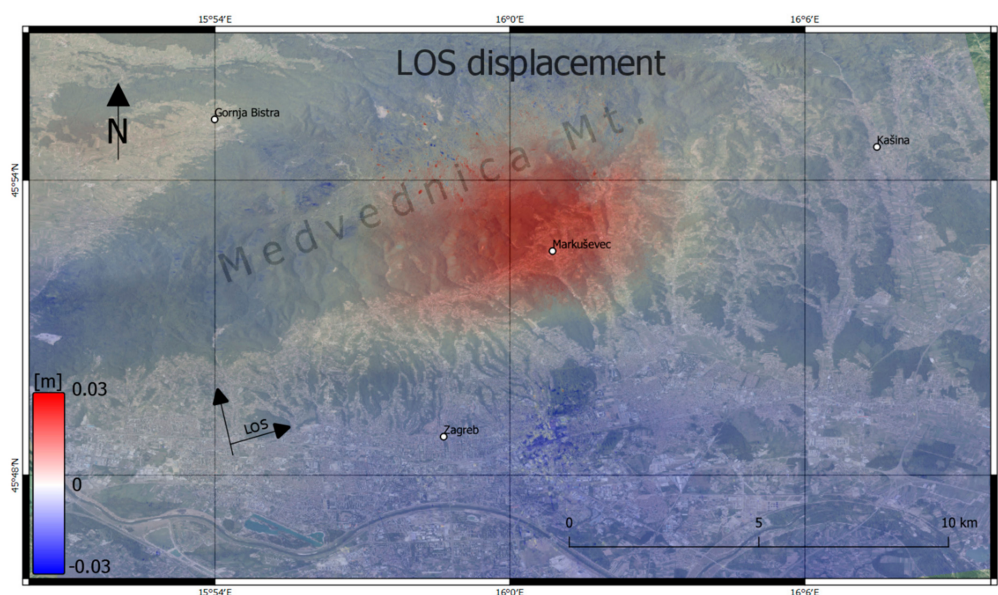
Two Sentinel-1A IW SLC images were processed to derive the co-seismic surface deformation at the Medvednica Mountains (Table 1). Space-borne SAR data are available on the Sentinel data hub [67]. The co-seismic displacement was investigated using differential interferometric synthetic aperture radar (DInSAR) technique [68]. The estimation of earthquake strength was based on the determination of the differential phase angle between two SAR images taken from almost the same satellite position at different times. The differential interferogram was filtered by relevant coherence (>0.2). Interferogram coherence values were moderate on average (0.46), although the affected area is covered with thick vegetation. Time series processing and post-earthquake analysis using radar interferometry were performed with the open-source Sentinel Application Platform (SNAP). Deformation was referenced with the line-of-sight (LOS) direction from radar. The LOS data were acquired by merging different swath phases and then unwrapped using SNAPHU (Statistical-Cost Network-Flow Algorithm for Phase Unwrapping). The results of co-seismic deformation were geocoded to a WGS84 geographic coordinate system (Figure 11). Figure 11 shows an unwrapped interferogram from which it is possible to identify the most affected area.

Figure 11. Unwrapped interferogram map indicating co-seismic line-of-sight (LOS) deformation of the 22 March 2020 earthquake.

The observed co-seismic deformation implies an approximately 3 cm uplift of the epicentral area that covers approximately 20 km².

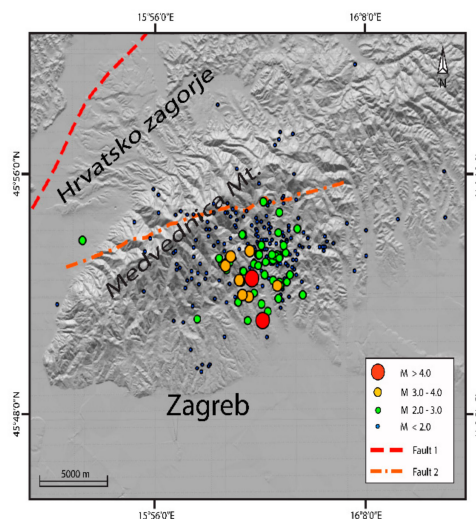
A set of 257 measurements was analyzed both spatially and temporally and processed for import into geological 3D modeling software. To achieve better visual insight, the hypocenters were scaled based on magnitude values (M_L) into four intervals: <2.0, 2.0–3.0, 3.0–4.0 and >4.0 (Figure 12).

Figure 12. Spatial distribution of earthquake epicenter locations in the period from 22 March to 1 April 2020 (the Zagreb 2020 earthquake sequence). Fault lines are simple projections of the two modeled fault plains from the deep subsurface of the Medvednica Mountains to the surface (see Supplement 1 and Figure 13).
