# Multi-Level Sensing Technologies in Landslide Research—Hrvatska Kostajnica Case Study, Croatia

**Abstract:** In March 2018, a landslide in Hrvatska Kostajnica completely destroyed multiple households. The damage was extensive, and lives were endangered. The question remains: Can it happen again? To enhance the knowledge and understanding of the soil and rock behaviour before, during, and after this geo-hazard event, multi-level sensing technologies in landslide research were applied. Day after the event field mapping and unmanned aerial vehicle (UAV) data were collected with the inspection of available orthophoto and “geo” data. For the landslide, a new geological column was developed with mineralogical and geochemical analyses. The application of differential interferometric synthetic aperture radar (DInSAR) for detecting ground surface displacement was undertaken in order to determine pre-failure behaviour and to give indications about post-failure deformations. In 2020, electrical resistivity tomography (ERT) in the landslide body was undertaken to determine the depth of the landslide surface, and in 2021 ERT measurements in the vicinity of the landslide area were performed t

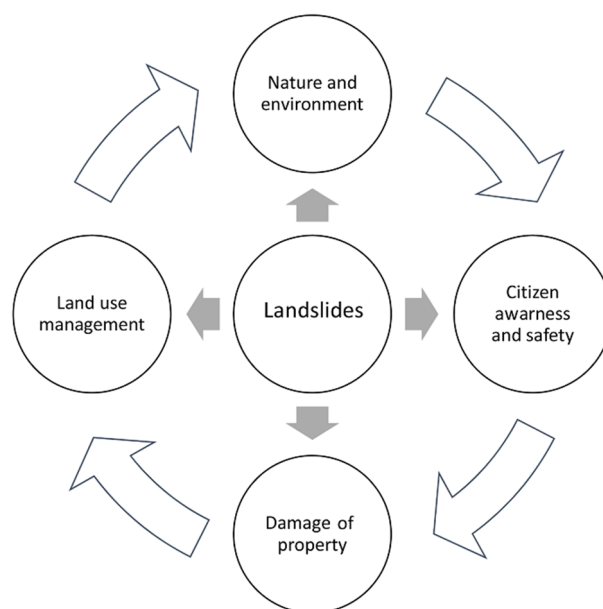
**Figure 1.** Landslides affect our environment and land use management and they can present danger to properties and safety.

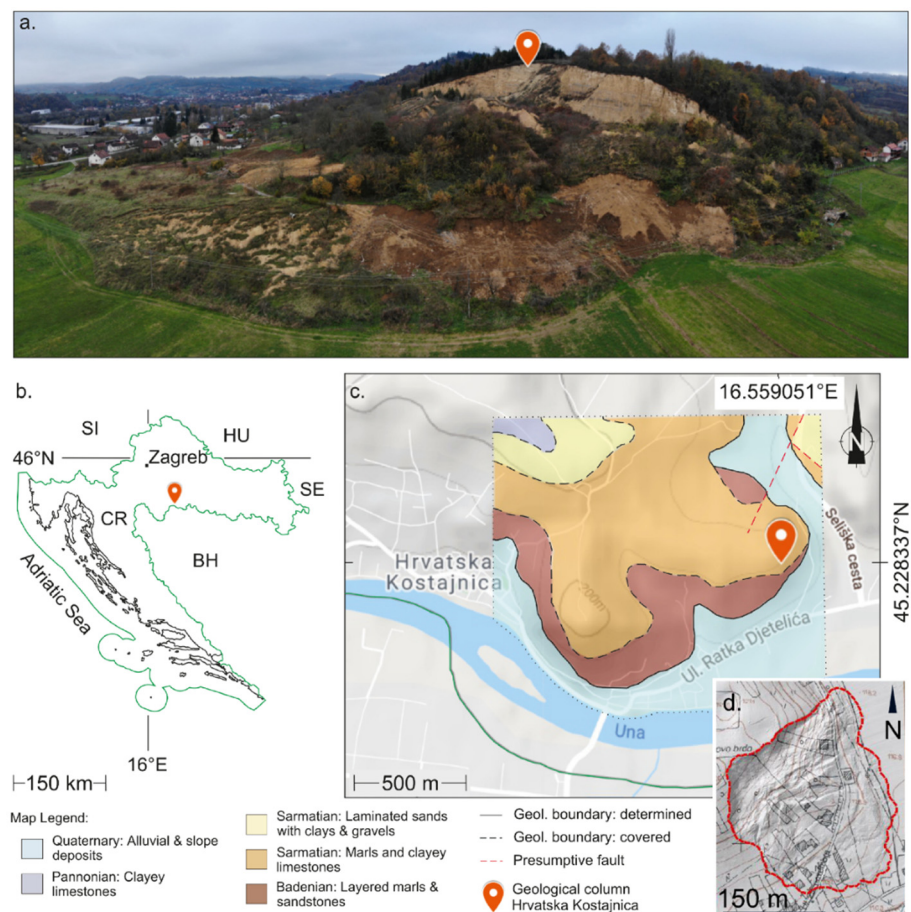
**Figure 2.** Study area: (a) landslide panorama in Hrvatska Kostajnica—on the south-eastern slope of Kubarnovo brdo, photo taken by unmanned aerial vehicle (UAV), by Croatian Geological Survey (CGS); (b) landslide location is in Croatia, near the border with Bosnia and Herzegovina; (c) basic geological data [23,24]; and (d) detail from topographic map (before landslide) overlaid with landslide area and detailed hillshade DEM (after landslide) and houses within landslide area: destroyed and damaged. Landslide area was defined by Croatian Geological Survey (CGS).

The study area is in Croatia in the Sisačko-Moslavina County in the city of Hrvatska Kostajnica (Figure 2a), near Una River, which is the border with Bosnia and Herzegovina (Figure 2b). The city area is 53 km<sup>2</sup> and the population is ~3000. Una River is situated ~400 m south from the Kubarnovo brdo where on 13 March 2018 the landslide occurred (Figure 2a–d). Una River is ~100 m above sea level, while Kubarnovo brdo peak is 188 m above sea level. Landslide is mainly rotational (only in some smaller parts can be considered as composite, a combination of types: rotational and translational slide and flow) [10,22], with area of ~300 × 300 m and maximum of ~61 m height difference: the highest part of the landslide (crown) is at 175 m above sea level while the lowest part of the landslide (toe) is 114 m above sea level. In combination with geological setting (Figure 2c), rapid temperature change (from below 0° to above zero which caused ~80 cm of snow cover to melt), period of rain, and Una River flooding, slope failure occurred (Figure 2d) and completely destroyed multiple households. The damage was extensive, and lives were endangered (Figure 3a–f).

Geographically, the study area is located on the south-eastern slope of Kubarnovo brdo, a hilly area (Figure 2a). The landslide toe part is on the flat area near Kostjničica stream situated only 100 m east from the landslide, and ~400 m south is Una River. Geologically [23], within Quaternary alluvial and silty flood sediments slope deposits are also present. The landslide occurred in Sarmatian marls and clayey limestones and Badenian layered marls and sandstones (Figure 2c) [24]. In terms of engineering geology [25,26] there is soil on the surface in the area. The thickness of soil varies but it is generally thinner than 0.5 m. At the main scarp area, the soil layer thickness is between 0.3 and 0.7 m. Below the soil layer, there is a layer of diluvial sediments which are represented by clays and clayish marls up to 3 m thickness (estimated). These sediments are weathered, and the weathered zone can reach up to 5 m of depth (estimated). This zone of weathered bedrock is generally below the stretch of the diluvial sediments. These weathered materials are (mainly) composed of sandy–silty-clays. Below the weathered zone bedrock follows, which is represented by clayish marls, silty marls, as well as layers of sandstones and weathered clayish limestones. The landslide has affected the soil layer, weathered zone, and bedrock, so the material characteristics vary in a wide range from soils to rocks. The actual study area covers  $\sim 500 \times 500$  m and it is somewhat wider than the landslide area.

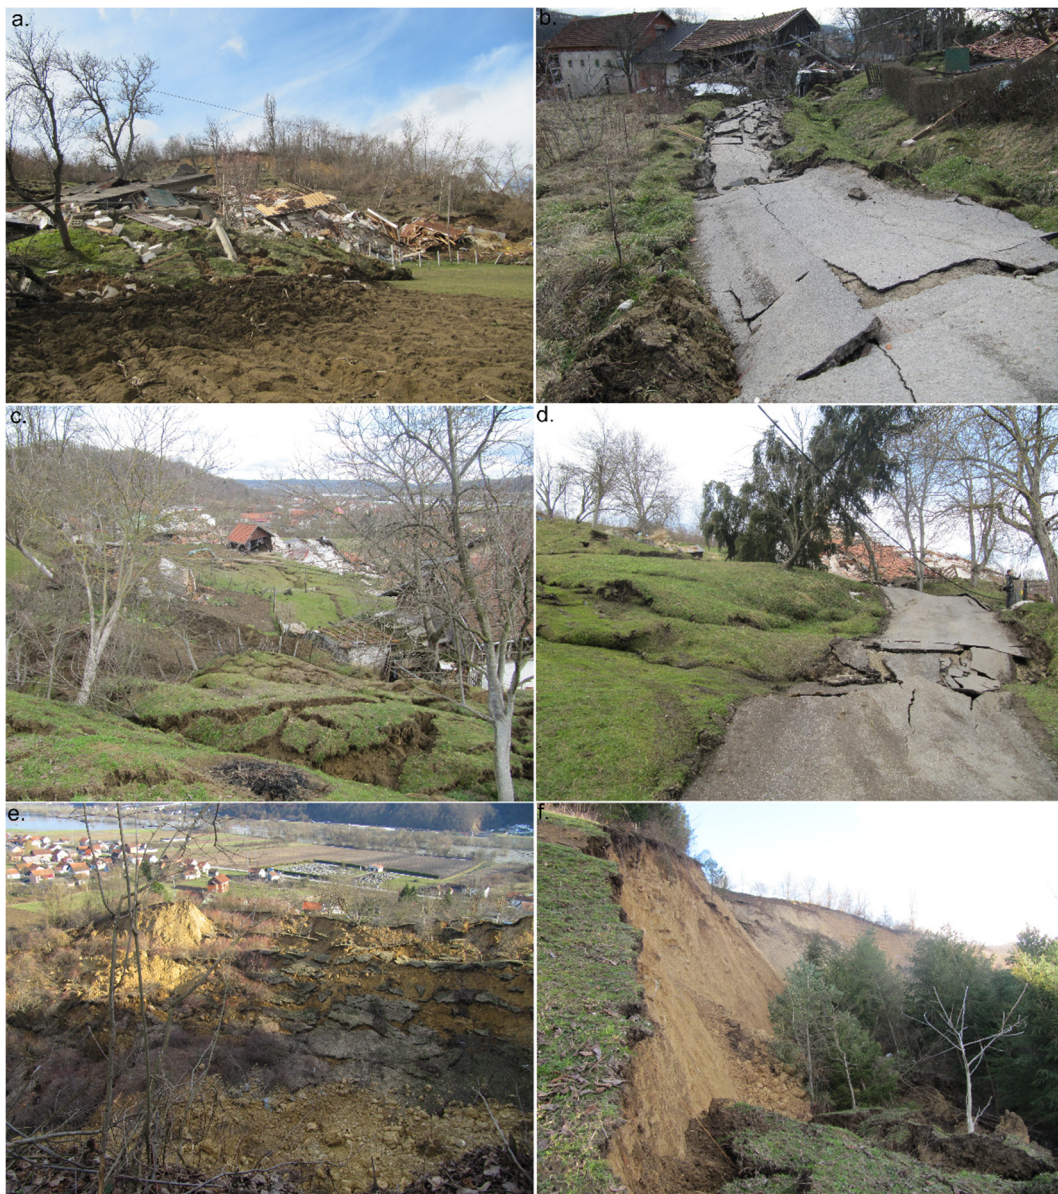
**Figure 3.** Hrvatska Kostajnica landslide damages: (a) completely destroyed houses; (b) completely destroyed road and damaged objects; (c) cracks and heavy terrain deformations; (d) flow like deformations on terrain surface; (e) view from main scarp toward flooding Una River; (f) landslide main scarp—almost 30 m at the highest point (photos by Croatian Geological Survey (CGS), day after the event, 14 March 2018).

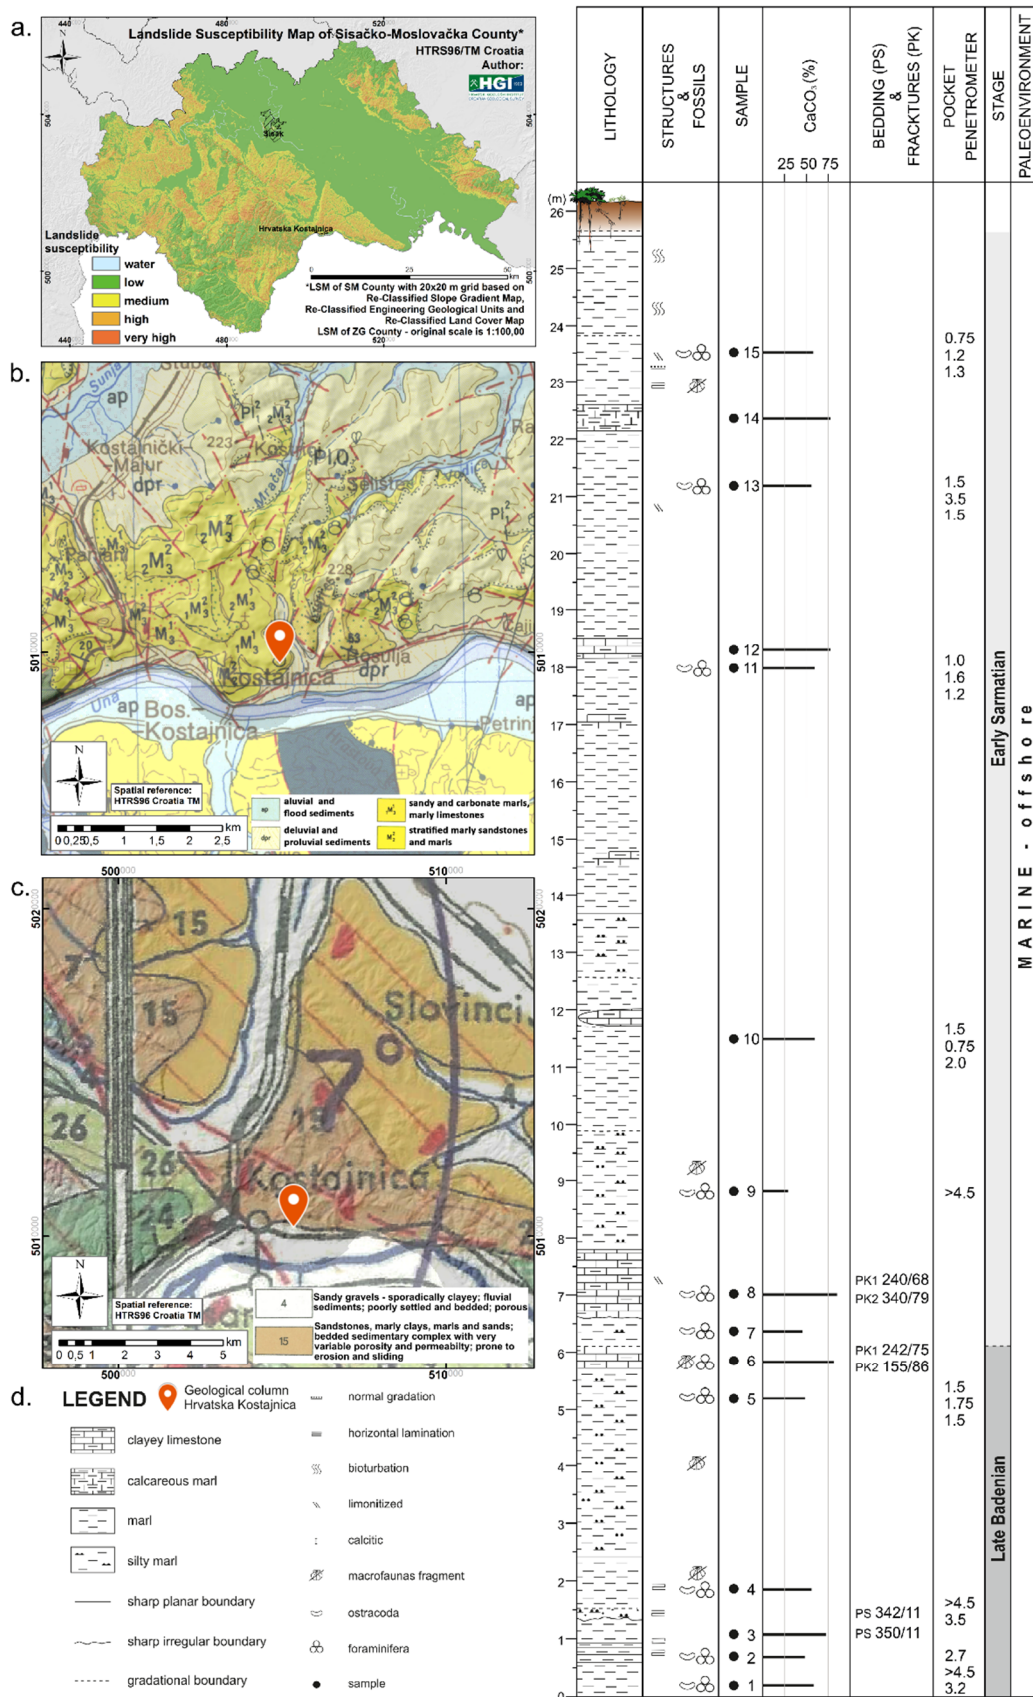
Figure 4. Study area “zoom in”: (a) landslide susceptibility Map of Sisačko-Moslavina County [4]; (b) detail from the Basic geological map [23]; (c) detail from the Engineering Geological Map [28]; and (d) the developed detailed geological column for Hrvatska Kostajnica landslide, modified after [24].

Available geological and landslide data were reviewed, mostly in the forms of existing guides and maps (Table 1, Figure 4a–d). Hrvatska Kostajnica is in the continental part of Croatia, where soils are commonly developed on the surface of the different types of sediments and slides in soils frequently occur (Figure 4a) [4].

This is also reflected in the Re-Classified Lithological Map of Croatia, where clayey materials and alluvial/diluvial deposits are depicted in the study area [6]. The 1:100,000 scale Basic geological map (Figure 4b) [23] and the 1:100,000 scale Geological Map of Sisačko-Moslavina County [29] indicate that Badenian (conglomerates, sandstones, marls, limestones) and Sarmatian (sandstones, gravels, sands, marls) deposits are present in the area with diluvial and proluvial Holocene sediments (sands, silts). Near the Una River, alluvial Holocene sediments (sands, gravels, silts, clays) are common [24]. In the 1:100,000 scale basic geological map, the presumptive fault locations are also marked (red dashed lines, Figure 4b) [23].

On the Landslide Susceptibility Map of Croatia, the wider area is generally depicted as prone to landslides [27], as on the 1:100,000 scale Landslide Susceptibility Map of Sisačko-Moslavina County (Figure 4a) [4] and on the 1:500,000 scale Engineering Geological Map of Yugoslavia, on which active landslide locations are marked with red semi circles (Figure 4c) [28]. The detail from the 1:500,000 scale Engineering Geological Map indicates that two units are present in the study area: (i) sandstones, marly clays, marls, and sands; Upper Neogene lacustrine bedded sedimentary complex with very variable porosity and permeability, prone to erosion and sliding (brown on map); and (ii) sandy gravels, sporadically clayey; Pleistocene–Holocene fluvial sediments, mostly covered with loam, poorly settled and bedded, rather porous (white on map). The topographic maps (1:5000 from NGA and the one developed from LIDAR data) in combination with developed landslide inventory for study area provides a good idea about the spatial distribution of landslides in this area (shown in detail in Figure 2d).

From the available geological and landslide data, it can be concluded that the area is generally prone to landslides (see Section 2.3. and Figure 4) [27,28]. The developed 26 m high detailed geological column at main scarp of Hrvatska Kostajnica landslide reveals that the landslide occurred mainly in the “marly” sediments, but clayey (weathered) limestone is also present at location [24]. The landslide affected the soil layer, weathered zone, and “bedrock”, but no clear sliding zone(s) was mapped on the field during geological column development and during engineering geological mapping in 2018 [25]. The assumption is that there were multiple weakened “zones” due to rhythmic changes within material, i.e., geological heterogeneity. Multiple field measurements and samples from the landslide head scarp were taken for the determination of on-site material characteristics and laboratory analysis. Field pocket penetrometer values and  $\text{CaCO}_3$  ratio variations also indicate differences in material properties (Figure 4d). Within weathered clayey limestones on bedding plains and fracture planes, “preferred” seepage and water “leakage” could

have occurred, and at the same time in these discontinuities thin clay layer(s) are sometimes present. Moreover, seven interchanges of marls–clayey limestone can be tracked at geological column/landslide main scarp (Figure 4). On this geological column, the main geo-specific characteristics of the location can be observed: the material is mainly marl with silts and it is interlayered with clayey limestone. This “interlayering” is common, and the materials are generally weathered. Moreover, the bulk analysis of marls shows that the main mineral components are calcite and clay minerals (i.e., smectite, illite, kaolinite, vermiculite), with some of them with high shrink-swell capacity [24]. All the “geo” data indicate multiple sliding surfaces as result of “rhythmic” changes within the material.

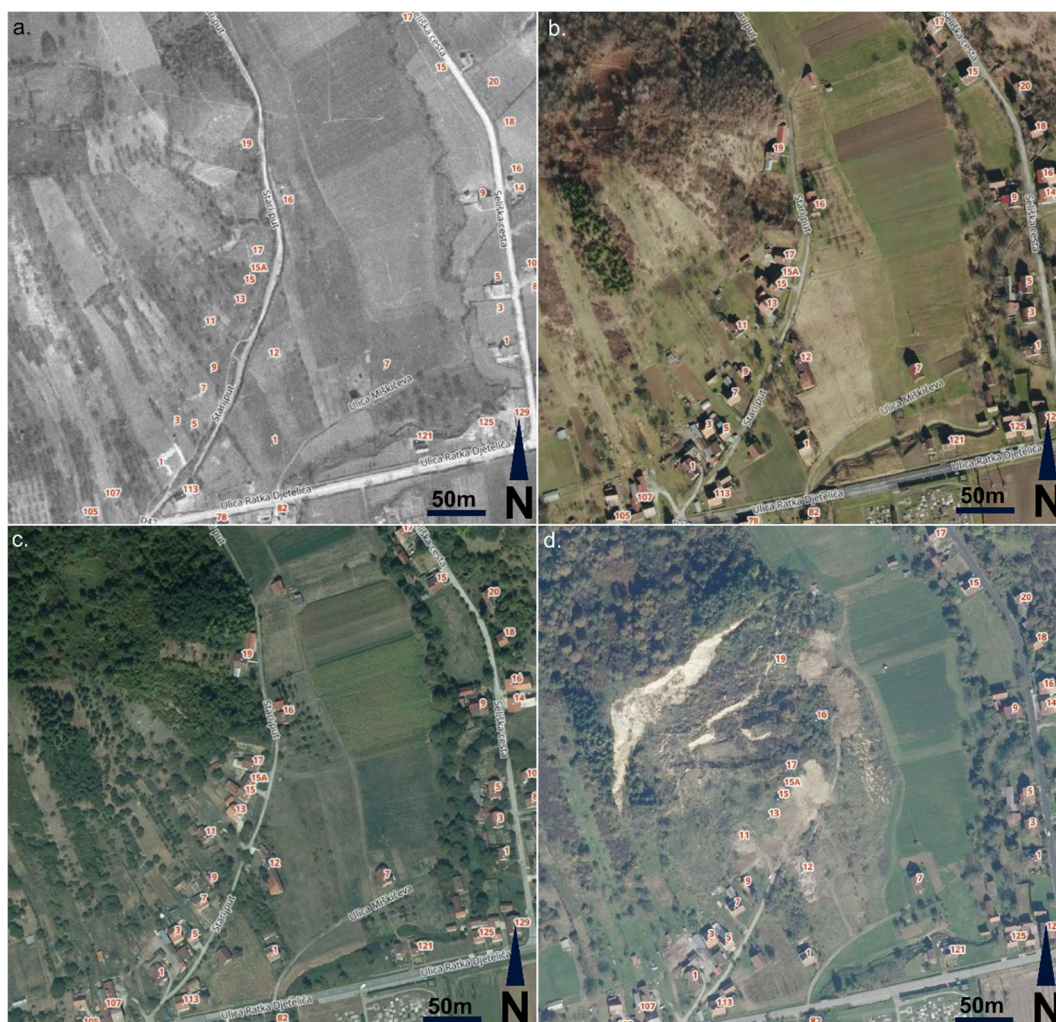
**Figure 5.** Hrvatska Kostajnica landslide area orthophotos from National Geodetic Administration of Croatia (NGA): (a) from 1968—historical data; (b) from 2016—pre-failure data; (c) from 2018—(recent) pre-failure data; and (d) from 2020—post-failure data.

Available orthophotos were reviewed as a source of land use change records (Figure 6a–d) [12,32]. In the historical photo from 1968, the landslide area is cropland without houses/objects (Figure 5a). On the “recent” photos from 2016 (Figure 5b) and 2018 (Figure 5c), the pre-failure situation can be observed: houses (1–19 house numbers), croplands, and woods. On the post-failure photo from 2020 (Figure 5d), it is visible that

houses 11–19 are removed (as they were destroyed or heavily damaged by landslide) and the croplands are destroyed. Houses 7 and 9 are damaged while houses 1, 3, and 5 are still endangered. In all figures (Figure 5a–d), the house numbers at Stari put Street are marked as reference. Stari put Street was completely destroyed by the landslide (Figure 5d).

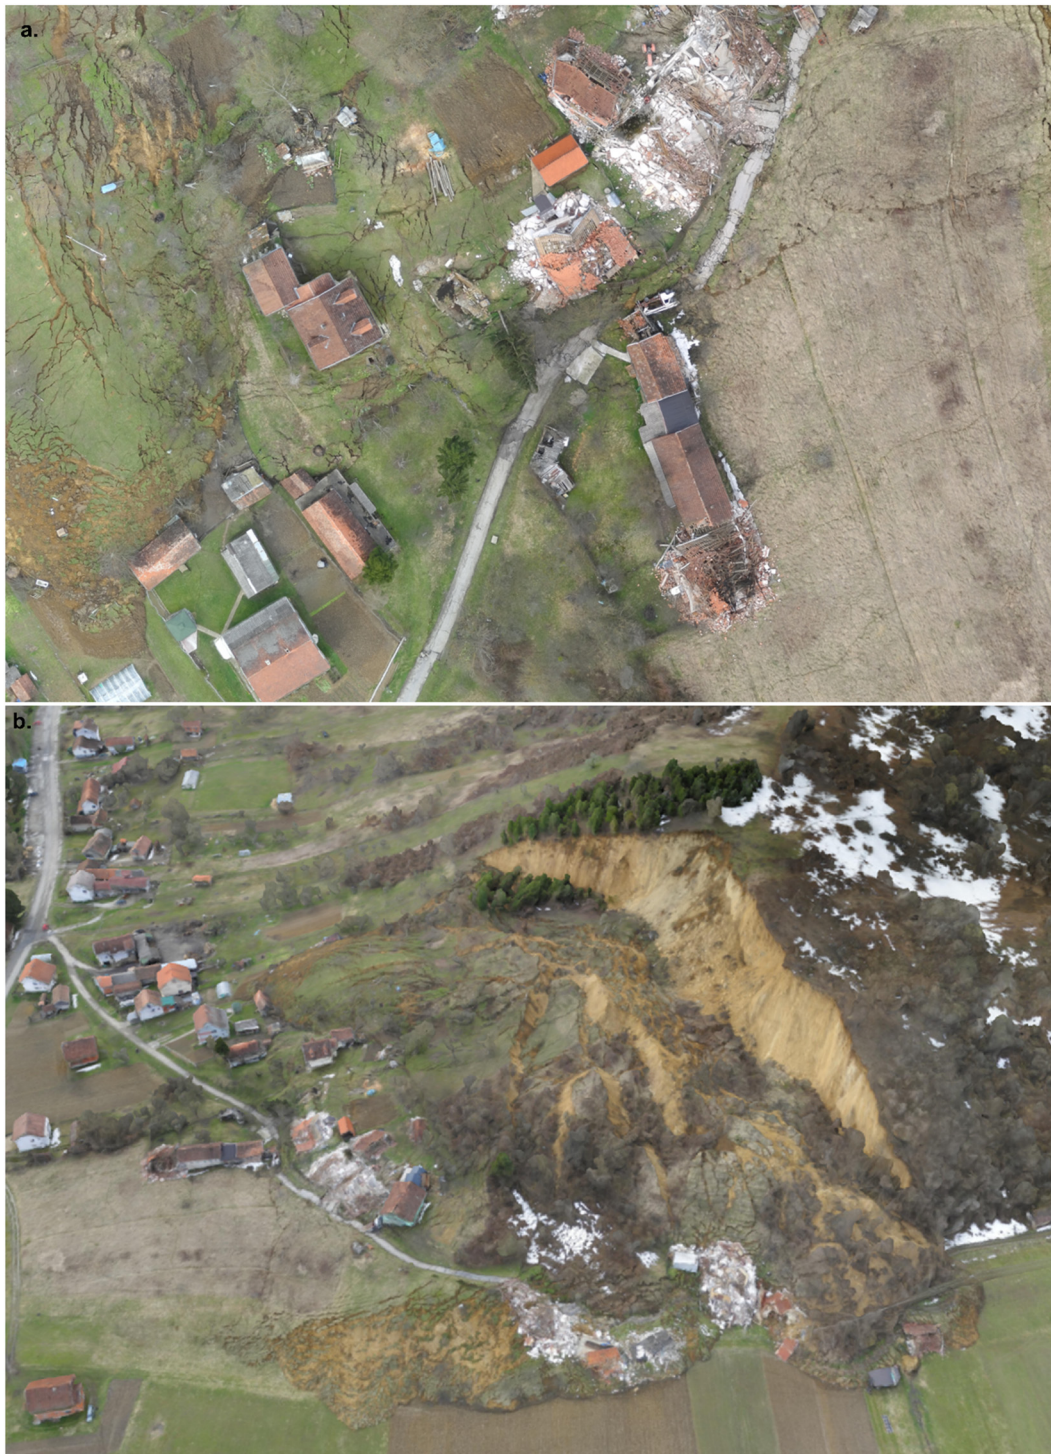
**Figure 6.** Hrvatska Kostajnica landslide area on 14 March 2018 (day after the event)—UAV data collected, analysed and developed by CGS: (a) detailed orthophoto data; and (b) 3D landslide area spatial model.

As the field mapping was carried out in an emergency (in only 1 day, 14 March 2018 by Croatian geological Survey), the detailed orthophotos taken by UAV on the same day proved to be a valuable source for follow-up landslide mapping [12,41,42]. The landslide area, features, and damages can be clearly distinguished in these photos, i.e., cm size features could be mapped (Figure 6a). For the more complete landslide area interpretation, a 3D landslide area spatial model was also developed (Figure 6b).

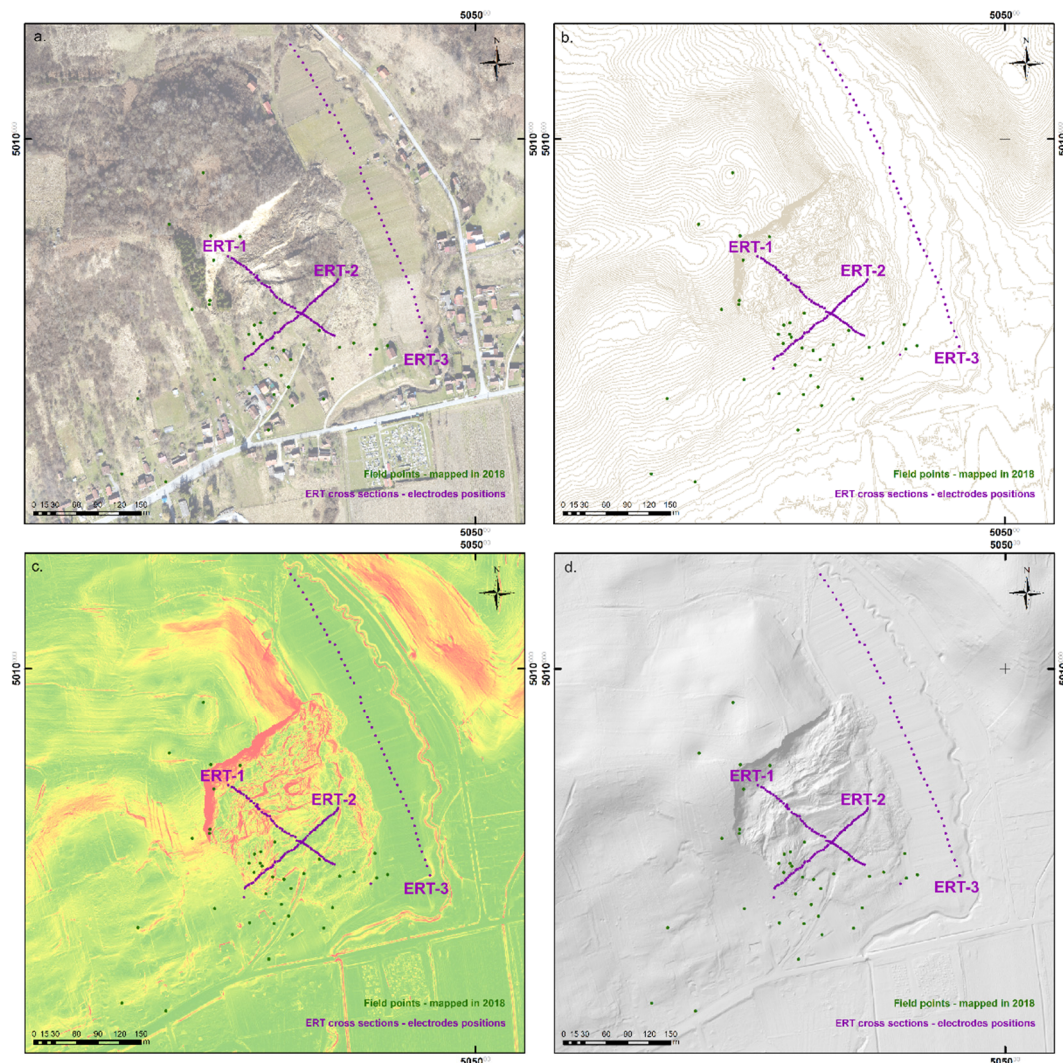
**Figure 7.** High resolution data from the Hrvatska Kostajnica area and landslide study area with mapped field points from 2018 and locations of ERT cross sections from 2020 and 2021: (a) detailed orthophoto from 2021; (b) 1 m contour lines based topography map; (c) detailed slope model; and (d) detailed terrain hillshade model.

Based on aerial LIDAR scanning, high resolution remote sensing data sets (Figure 7a–d) were used in landslide model development [6,43–45]. With the combination of a detailed orthophoto (Figure 7a), 1 m contour lines developed from LIDAR data (Figure 7b), a detailed slope model (Figure 7c), and terrain hillshade model (Figure 7d), quality terrain landslide surface model development (2D) was possible (Figure 8) [12,46]. These high

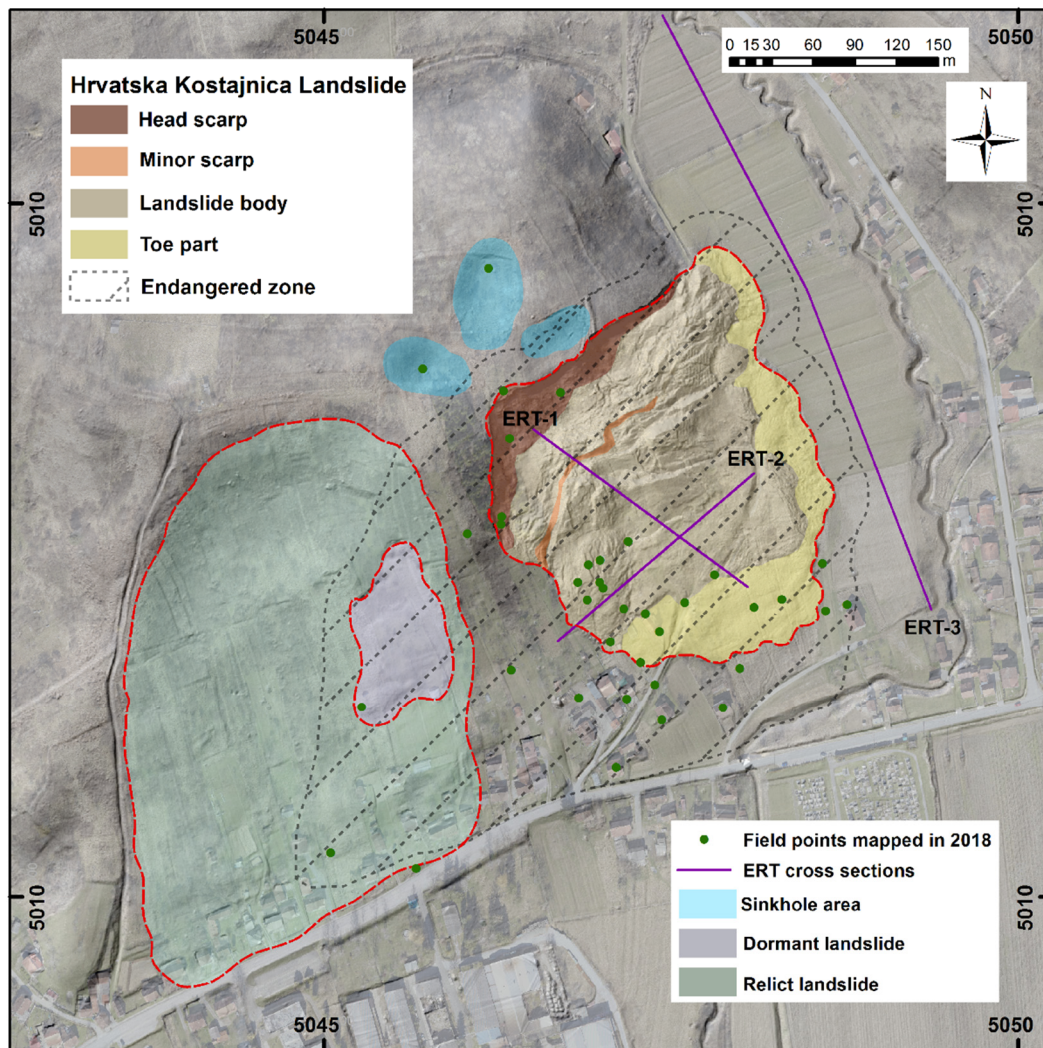
**Figure 8.** New Hrvatska Kostajnica Landslide Map with marked areas of active, dormant and relict landslide. Landslide areas are depicted with red dashed lines. On the map re-defined area of landslide(s) endangered zone is also marked (grey dashed polygon area).

Using detailed LIDAR based data, precise terrain landslide surface model development was possible, which served as baseline for new landslide map development [47]. A precise terrain landslide surface model was also used for landslide features re-evaluation and mapping and the re-evaluation of possible endangered zones. As a result, the New Hrvatska Kostajnica Landslide Map was developed (Figure 8). The map was also field verified in September 2021 (within GeoTwinn project, with experts from the Geological Survey of Denmark and Greenland, GEUS).

On the New Hrvatska Kostajnica Landslide Map, all the areas which are/or could be influenced by landslide(s) are reviewed and as a result the area of Endangered zone is redefined [43,45,46]. Within the Hrvatska Kostajnica landslide body, there is still activity: the erosion of the head scarp area due to atmospheric influences is an ongoing process i.e., the landslide is developing retrogressively [6,44,47]. Moreover, the settlement of the colluvium at the toe part area is ongoing at some (minor) rate. In the landslide body, there are still many wide-open cracks which are not stabilized. In the case of extreme rain, new movements within landslide body are possible. That is the reason for the endangered zone encircling the area of the active landslide body (same as on field map and report from 2018), but after revision of the available data the endangered zone was enlarged and an area with no traces of deformations was included with the area of the dormant landslide. The reason

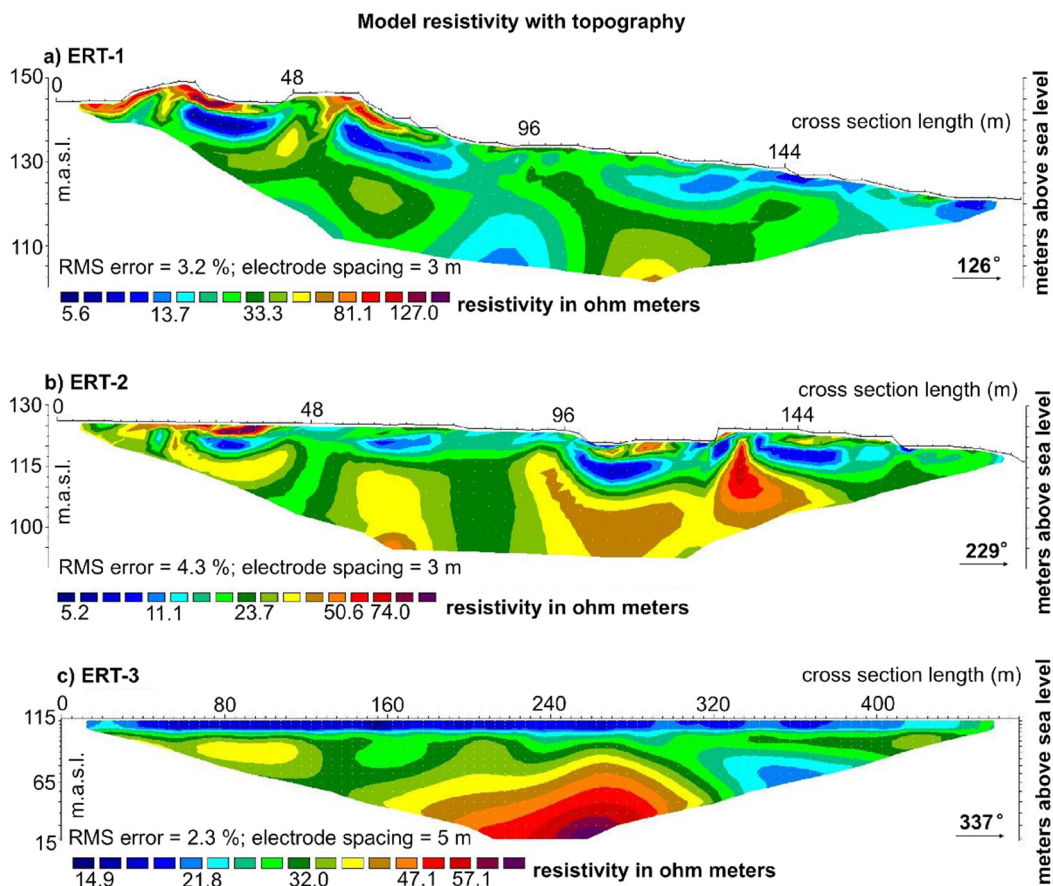
**Figure 9.** Electrical resistivity tomography results: (a) ERT-1 in the landslide body, cross section is oriented along the movement direction; (b) ERT-2 in the landslide body, cross section is oriented vertically on the movement direction; and (c) ERT-3 in the vicinity of the landslide, cross section is located in the “undisturbed soils”. On the ERT-1 and ERT-2 highly deformed/disturbed near surface areas can be depicted while on ERT-3 paleo-relief can be interpreted.

ERT-1 and ERT-2 were measured in the landslide body in October 2020, while ERT-3 was measured in the immediate vicinity of the landslide, in the Quaternary sediments in May 2021. Surveys were conducted using the Wenner–Schlumberger array for ERT-1, ERT-2, and ERT-3 at a frequency of 7.15 Hz and a maximum phase of 200 between the voltage signal and the current signal. The ERT-1 and ERT-2 were measured with 64 steel electrodes and the length of the cross sections was 189 m with an exploration depth of about 40 m. ERT-3 was measured with 48 electrodes and the length of the cross sections was 470 m with an exploration depth of about 95 m.

The apparent electrical resistivity data were inverted using the RES2DINV software [50] to obtain the 2D electrical resistivity images of the subsurface model [55–58]. The ERT-1 and ERT-2 were measured in a landslide body, and therefore the topography effect was taken into account during the execution of the data set inversion in RES2DINV software. The optimization method adjusts the 2D electrical resistivity model trying to iteratively reduce the difference between the calculated and measured apparent resistivity values [59]. The root-mean-squared (RMS) error provides a measurement of this difference. All three cross sections have acceptable RMS values: for ERT-1 RMS, 3.2%; for ERT-2 RMS, 4.3%; and for ERT-3 RMS, 2.3%. The 2D model sections obtained from data inversion are presented as resistivity tomograms (Figure 9a–c).

The tomograms measured in the landslide body (ERT-1 and ERT-2) show the variation of modelled electrical resistivity in-depth and along the line of investigation. ERT-1 and ERT-2 show a distinctly heterogeneous structure, both laterally and vertically, especially near the surface, but this was expected due to landslide presence and highly deformed/disturbed areas. There are low and high resistivity zones in these sections, but in general the values of resistivity are low. The aim of measuring these cross sections (ERT-1 and ERT-2) was to establish the depth(s) of sliding zone(s). The ERT-3 was measured outside the landslide zone in the undisturbed area/sediments/Quaternary deposits and consequently the variation of modelled electrical resistivity is less expressed. The aim of measuring this cross section (ERT-3) was to establish the “base resistance values of the undisturbed soil”.

On the ERT-1 and ERT-2, measured in the landslide body, where the material is deformed, the near surface variations in resistivity are more expressed, but still for the colluvial material is generally in the range of 5–20 Ohm meters. Somewhat different but still relatively low resistance values for ERT-1 and ERT-2 in the “bedrock” can be explained by the lithology and “interlayering” of the material.

In the vicinity of the landslide, the ERT-3 resistance values from 5 to 25 Ohm meters represent (mainly) saturated deposits made of clay, silt, and gravel. The thickness of these deposits are ~12 m (Quaternary deposits, Alluvial). Below that, the paleo-relief surface can be interpreted at the depth ~50–65 m. In the zone between the alluvial deposits and paleo-relief, surface resistance values vary from 25 to 50 Ohm meters. This “zone” is probably represented with Quaternary slope deposits in the upper part of the section and

If we compare the resistance measurements of the “bedrock” on the ERT-3 with the ERT-1 and ERT-2 measured in the landslide body, we can conclude that “bedrock” is the same, but there are probably variations in the depth of the weathered zone and in the heterogeneity of the structure, i.e., in the number and thickness of “interlayers” (Figure 9a–c).

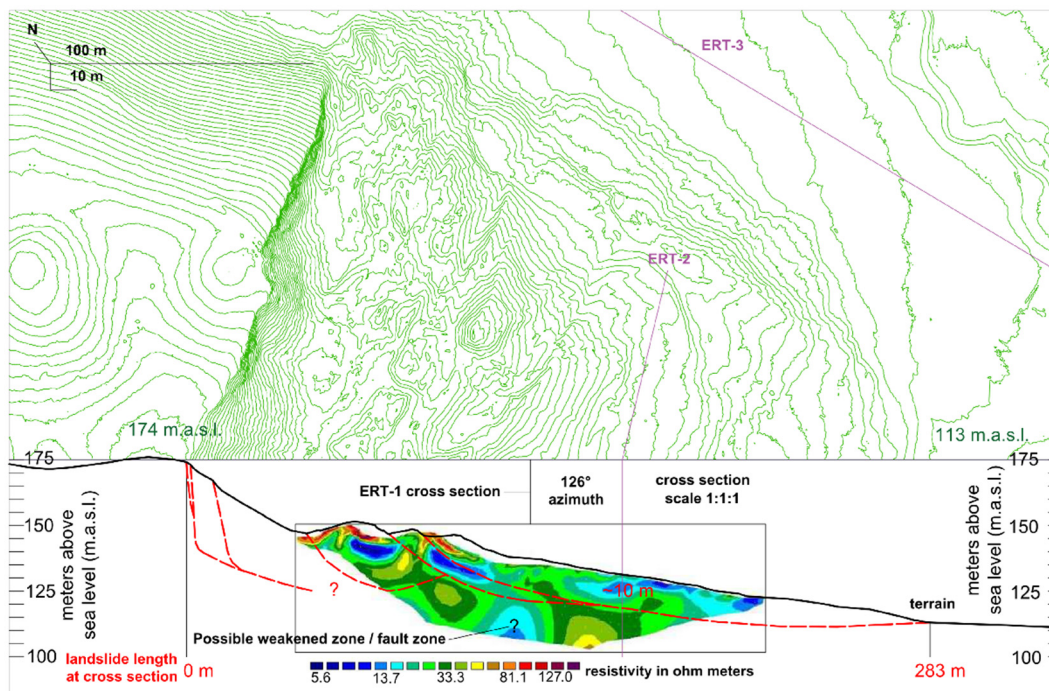
**Figure 10.** Hrvatska Kostajnica landslide cross section (parallel to movement) and interpreted ERT-1 data. At cross section area the length of the landslide is 283 m with multiple slide surfaces. The depth of the interpreted sliding surfaces varies from ~20–30 m at head scarp area, to ~10–20 m at landslide body area and ~1–10 m at landslide toe part area. In the middle part of the cross section possible fault zone is present (marked with question mark). The contour line interval on the topographical map is 1 m.

From the detailed LIDAR data, detailed terrain/landslide cross sections were developed, and the ERT measurements conducted on these cross sections were interpreted as first step towards Hrvatska Kostajnica landslide model development (Figures 10 and 11). Measured ERT-1 and ERT-2 length is 190 m (in field) while the cross-section length with data for interpretation is ~180 m with a depth of ~35 m.

ERT was applied on the Hrvatska Kostajnica landslide to determine the physical properties of soil and rock, subsurface lithology, groundwater condition and geometry of the slide surface [11,40,48,55,60]. According to the measured resistances, it can be concluded that the landslide has multiple sliding surfaces and that the highly deformed materials are present mainly in the main body of the landslide (Figures 10 and 11). The cross

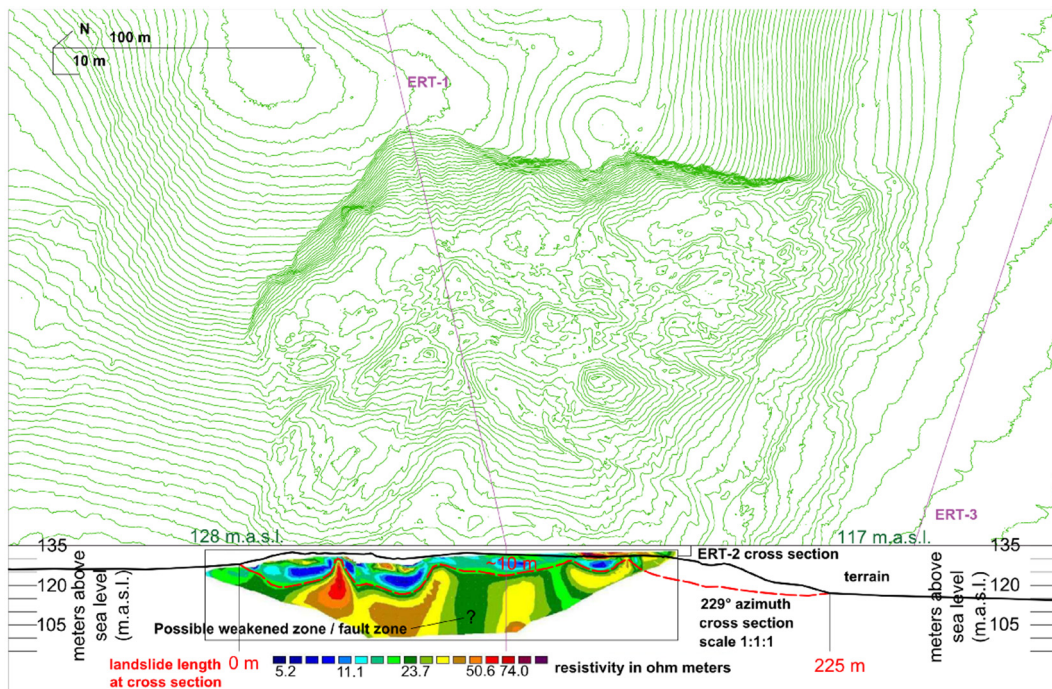
**Figure 11.** Hrvatska Kostajnica landslide cross section (perpendicular to movement) and interpreted ERT-2 data. At cross section area the length of the landslide is 225 m with slide surface at the depth of  $\sim 10$  m. In the middle part of the cross section possible fault zone is present (marked with question mark). The contour line interval on the topographical map is 1 m.
