# Multi-Level Sensing Technologies in Landslide Research—Hrvatska Kostajnica Case Study, Croatia

**Abstract:** In March 2018, a landslide in Hrvatska Kostajnica completely destroyed multiple households. The damage was extensive, and lives were endangered. The question remains: Can it happen again? To enhance the knowledge and understanding of the soil and rock behaviour before, during, and after this geo-hazard event, multi-level sensing technologies in landslide research were applied. Day after the event field mapping and unmanned aerial vehicle (UAV) data were collected with the inspection of available orthophoto and “geo” data. For the landslide, a new geological column was developed with mineralogical and geochemical analyses. The application of differential interferometric synthetic aperture radar (DInSAR) for detecting ground surface displacement was undertaken in order to determine pre-failure behaviour and to give indications about post-failure deformations. In 2020, electrical resistivity tomography (ERT) in the landslide body was undertaken to determine the depth of the landslide surface, and in 2021 ERT measurements in the vicinity of the landslide area were performed t

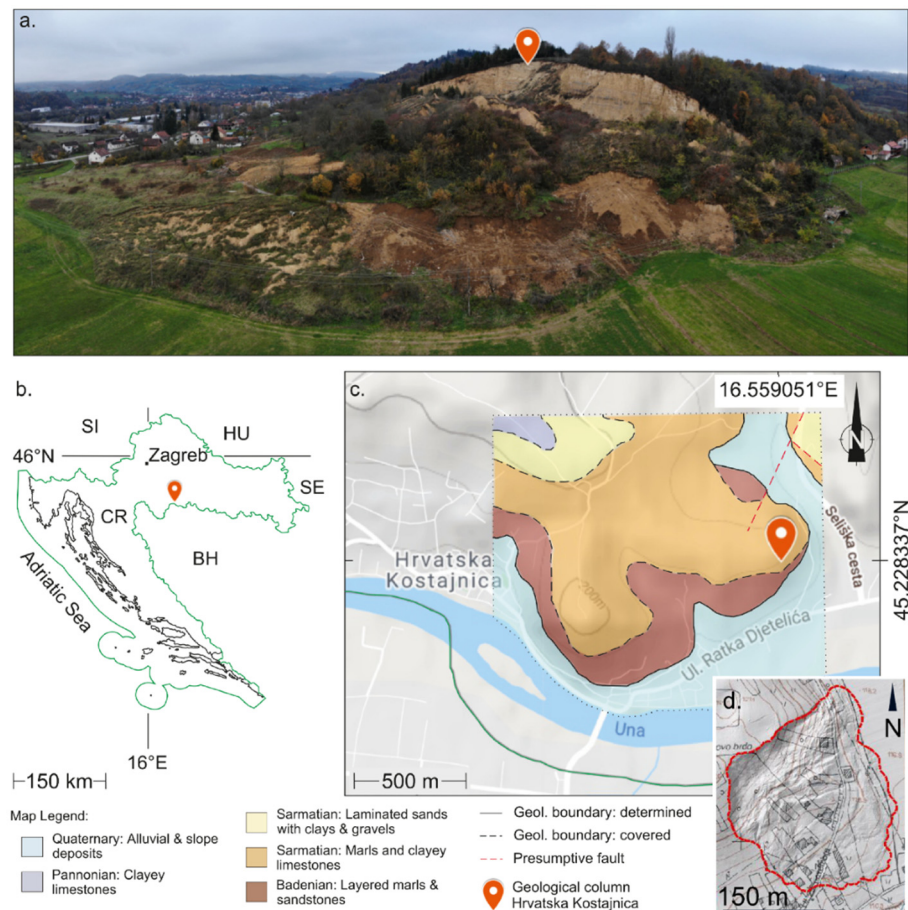
**Figure 2.** Study area: (a) landslide panorama in Hrvatska Kostajnica—on the south-eastern slope of Kubarnovo brdo, photo taken by unmanned aerial vehicle (UAV), by Croatian Geological Survey (CGS); (b) landslide location is in Croatia, near the border with Bosnia and Herzegovina; (c) basic geological data [23,24]; and (d) detail from topographic map (before landslide) overlaid with landslide area and detailed hillshade DEM (after landslide) and houses within landslide area: destroyed and damaged. Landslide area was defined by Croatian Geological Survey (CGS).

The study area is in Croatia in the Sisačko-Moslavina County in the city of Hrvatska Kostajnica (Figure 2a), near Una River, which is the border with Bosnia and Herzegovina (Figure 2b). The city area is 53 km<sup>2</sup> and the population is ~3000. Una River is situated ~400 m south from the Kubarnovo brdo where on 13 March 2018 the landslide occurred (Figure 2a–d). Una River is ~100 m above sea level, while Kubarnovo brdo peak is 188 m above sea level. Landslide is mainly rotational (only in some smaller parts can be considered as composite, a combination of types: rotational and translational slide and flow) [10,22], with area of ~300 × 300 m and maximum of ~61 m height difference: the highest part of the landslide (crown) is at 175 m above sea level while the lowest part of the landslide (toe) is 114 m above sea level. In combination with geological setting (Figure 2c), rapid temperature change (from below 0° to above zero which caused ~80 cm of snow cover to melt), period of rain, and Una River flooding, slope failure occurred (Figure 2d) and completely destroyed multiple households. The damage was extensive, and lives were endangered (Figure 3a–f).

Geographically, the study area is located on the south-eastern slope of Kubarnovo brdo, a hilly area (Figure 2a). The landslide toe part is on the flat area near Kostjničica stream situated only 100 m east from the landslide, and ~400 m south is Una River. Geologically [23], within Quaternary alluvial and silty flood sediments slope deposits are also present. The landslide occurred in Sarmatian marls and clayey limestones and Badenian layered marls and sandstones (Figure 2c) [24]. In terms of engineering geology [25,26] there is soil on the surface in the area. The thickness of soil varies but it is generally thinner than 0.5 m. At the main scarp area, the soil layer thickness is between 0.3 and 0.7 m. Below the soil layer, there is a layer of diluvial sediments which are represented by clays and clayish marls up to 3 m thickness (estimated). These sediments are weathered, and the weathered zone can reach up to 5 m of depth (estimated). This zone of weathered bedrock is generally below the stretch of the diluvial sediments. These weathered materials are (mainly) composed of sandy–silty-clays. Below the weathered zone bedrock follows, which is represented by clayish marls, silty marls, as well as layers of sandstones and weathered clayish limestones. The landslide has affected the soil layer, weathered zone, and bedrock, so the material characteristics vary in a wide range from soils to rocks. The actual study area covers  $\sim 500 \times 500$  m and it is somewhat wider than the landslide area.

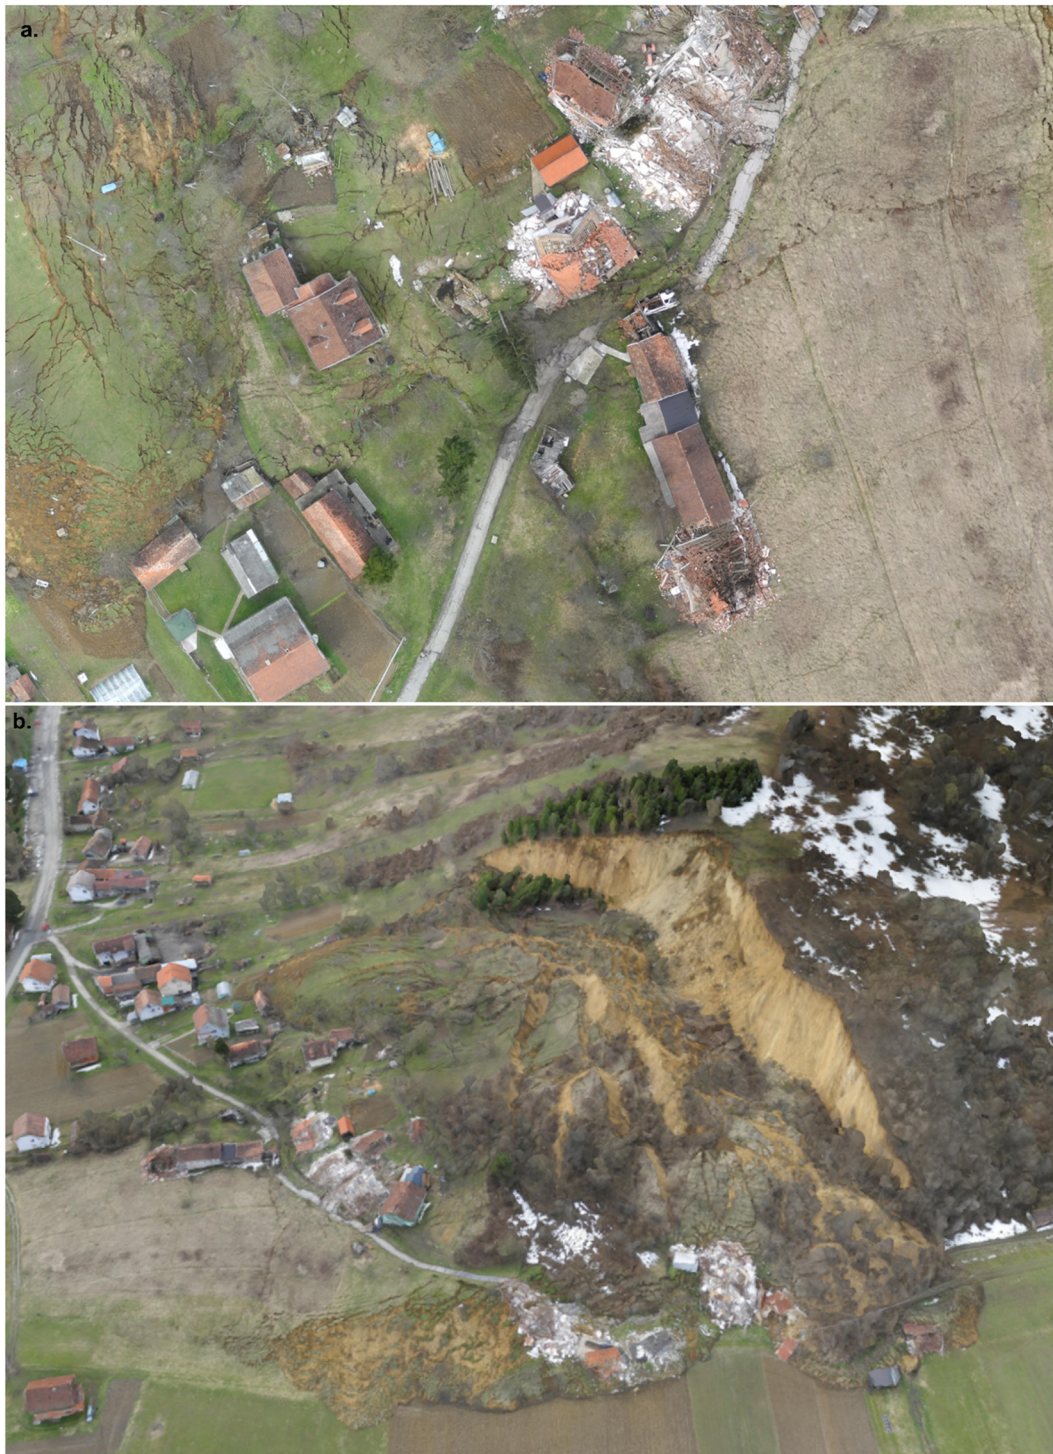
**Figure 6.** Hrvatska Kostajnica landslide area on 14 March 2018 (day after the event)—UAV data collected, analysed and developed by CGS: (a) detailed orthophoto data; and (b) 3D landslide area spatial model.

As the field mapping was carried out in an emergency (in only 1 day, 14 March 2018 by Croatian geological Survey), the detailed orthophotos taken by UAV on the same day proved to be a valuable source for follow-up landslide mapping [12,41,42]. The landslide area, features, and damages can be clearly distinguished in these photos, i.e., cm size features could be mapped (Figure 6a). For the more complete landslide area interpretation, a 3D landslide area spatial model was also developed (Figure 6b).

resolution data were cross checked with acquired mapped data from 2018 and ERT data from 2020 and 2021. For the 3D landslide model development UAV model from 2018 (Figure 6b), cross sections from detailed DEMs and ERT measurements (cross sections) were analyzed and interpreted (Figures 10 and 11).

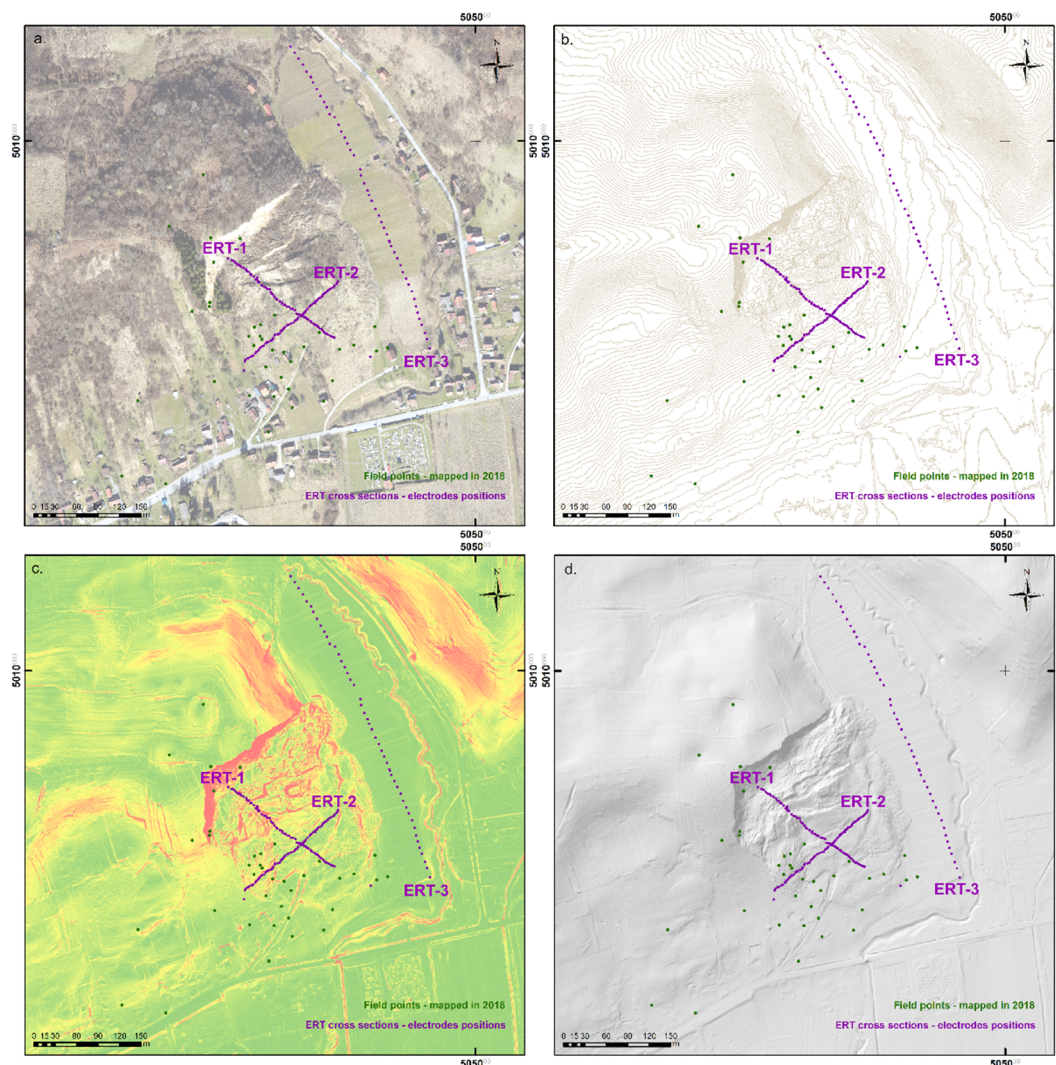
**Figure 7.** High resolution data from the Hrvatska Kostajnica area and landslide study area with mapped field points from 2018 and locations of ERT cross sections from 2020 and 2021: (a) detailed orthophoto from 2021; (b) 1 m contour lines based topography map; (c) detailed slope model; and (d) detailed terrain hillshade model.

Based on aerial LIDAR scanning, high resolution remote sensing data sets (Figure 7a–d) were used in landslide model development [6,43–45]. With the combination of a detailed orthophoto (Figure 7a), 1 m contour lines developed from LIDAR data (Figure 7b), a detailed slope model (Figure 7c), and terrain hillshade model (Figure 7d), quality terrain landslide surface model development (2D) was possible (Figure 8) [12,46]. These high
