# Multi-Level Sensing Technologies in Landslide Research—Hrvatska Kostajnica Case Study, Croatia

**Abstract:** In March 2018, a landslide in Hrvatska Kostajnica completely destroyed multiple households. The damage was extensive, and lives were endangered. The question remains: Can it happen again? To enhance the knowledge and understanding of the soil and rock behaviour before, during, and after this geo-hazard event, multi-level sensing technologies in landslide research were applied. Day after the event field mapping and unmanned aerial vehicle (UAV) data were collected with the inspection of available orthophoto and “geo” data. For the landslide, a new geological column was developed with mineralogical and geochemical analyses. The application of differential interferometric synthetic aperture radar (DInSAR) for detecting ground surface displacement was undertaken in order to determine pre-failure behaviour and to give indications about post-failure deformations. In 2020, electrical resistivity tomography (ERT) in the landslide body was undertaken to determine the depth of the landslide surface, and in 2021 ERT measurements in the vicinity of the landslide area were performed t

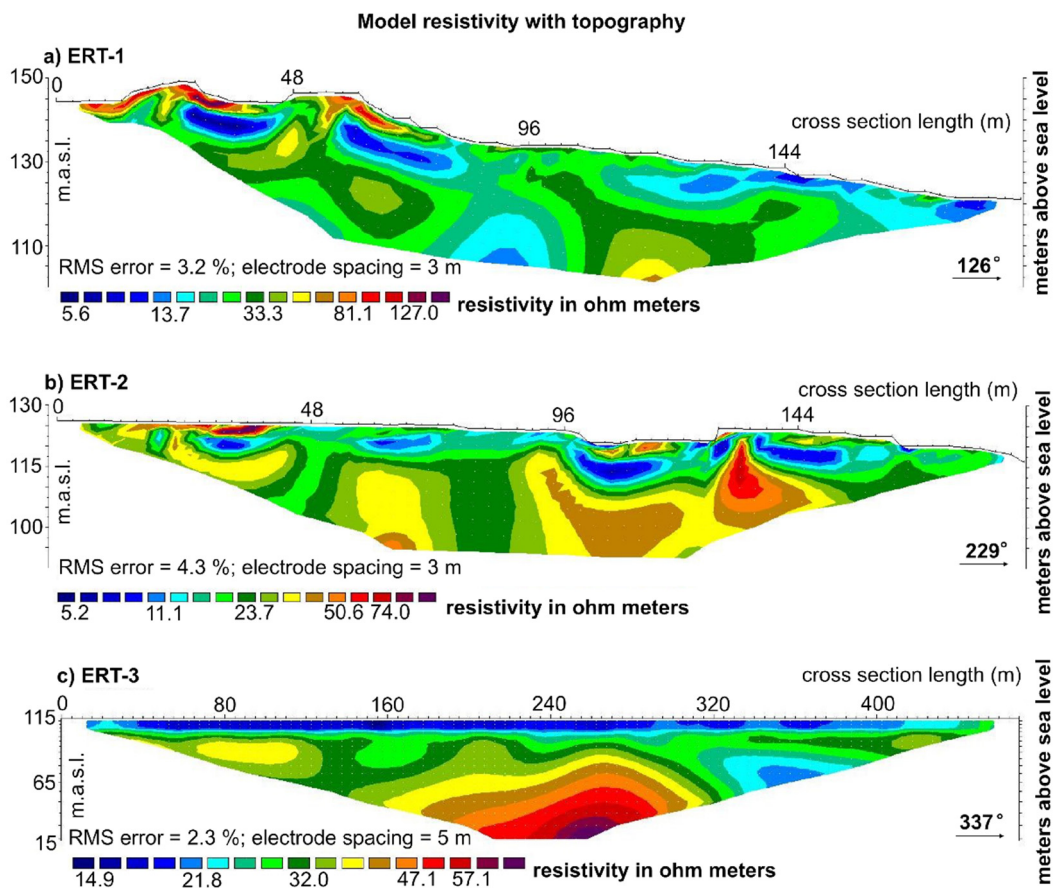
**Figure 9.** Electrical resistivity tomography results: (a) ERT-1 in the landslide body, cross section is oriented along the movement direction; (b) ERT-2 in the landslide body, cross section is oriented vertically on the movement direction; and (c) ERT-3 in the vicinity of the landslide, cross section is located in the “undisturbed soils”. On the ERT-1 and ERT-2 highly deformed/disturbed near surface areas can be depicted while on ERT-3 paleo-relief can be interpreted.

The apparent electrical resistivity data were inverted using the RES2DINV software [50] to obtain the 2D electrical resistivity images of the subsurface model [55–58]. The ERT-1 and ERT-2 were measured in a landslide body, and therefore the topography effect was taken into account during the execution of the data set inversion in RES2DINV software. The optimization method adjusts the 2D electrical resistivity model trying to iteratively reduce the difference between the calculated and measured apparent resistivity values [59]. The root-mean-squared (RMS) error provides a measurement of this difference. All three cross sections have acceptable RMS values: for ERT-1 RMS, 3.2%; for ERT-2 RMS, 4.3%; and for ERT-3 RMS, 2.3%. The 2D model sections obtained from data inversion are presented as resistivity tomograms (Figure 9a–c).

If we compare the resistance measurements of the “bedrock” on the ERT-3 with the ERT-1 and ERT-2 measured in the landslide body, we can conclude that “bedrock” is the same, but there are probably variations in the depth of the weathered zone and in the heterogeneity of the structure, i.e., in the number and thickness of “interlayers” (Figure 9a–c).
