The Zagreb (Croatia) M5.5 Earthquake on 22 March 2020

Abstract: On 22 March 2020, Zagreb was struck by an M5.5 earthquake that had been expected for more than 100 years and revealed all the failures in the construction of residential buildings in the Croatian capital, especially those built in the first half of the 20th century. Because of that, extensive seismological, geological, geodetic and structural engineering surveys were conducted immediately after the main shock. This study provides descriptions of damage, specifying the building performances and their correlation with the local soil characteristics, i.e., seismic motion amplification. Co-seismic vertical ground displacement was estimated, and the most affected area is identified according to Sentinel-1 interferometric wide-swath data. Finally, preliminary 3D structural modeling of the earthquake sequence was performed, and two major faults were modeled using inverse distance weight (IDW) interpolation of the grouped hypocenters. The first-order assessment of seismic amplification (due to site conditions) in the Zagreb area for the M5.5 earthquake shows that ground motions of approximately 0.16–0.19 g were amplified at l

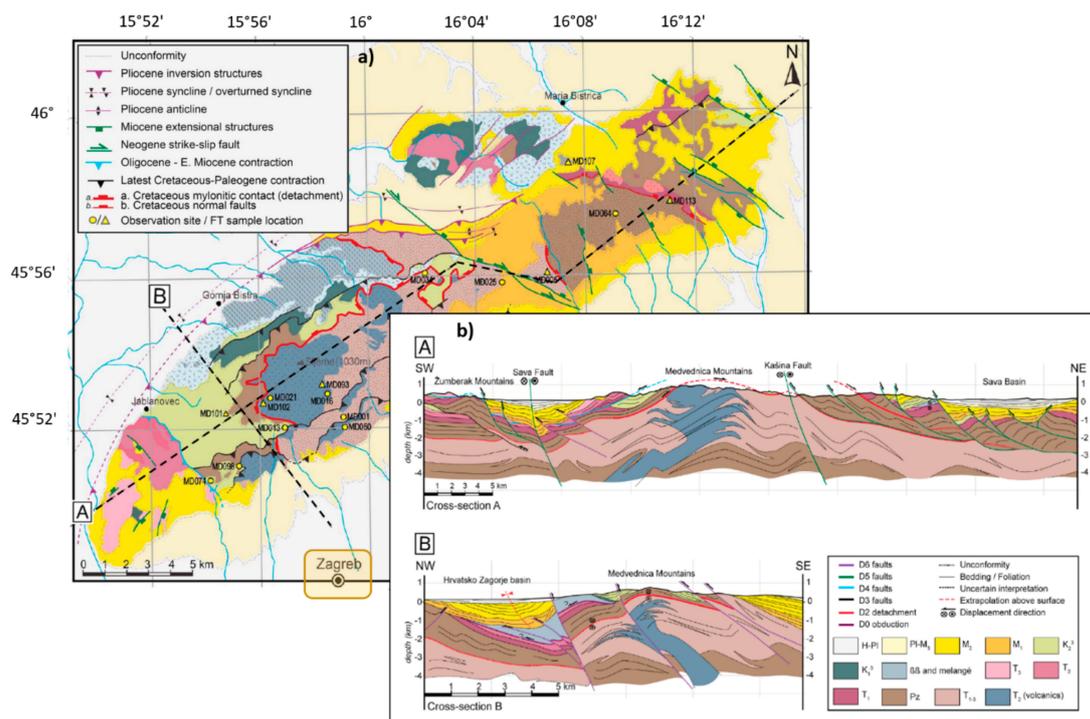
Figure 1. (a) Geological map of the Medvednica Mountains. The map shows the location of the cross-sections A and B; (b) Cross-sections across the Medvednica Mountains: (A) longitudinal (SW–NE) and (B) transversal (NW–SE) (after [11]).

The Medvednica Mountains are composed of a Paleozoic to Mesozoic metamorphic core overlain by non-metamorphic Mesozoic and Cenozoic rocks ([13–15]; Figure 1a). All units are truncated by normal and reverse faults and are surrounded by the Miocene–Quaternary deposits of the Pannonian Basin.

Van Gelder et al. [11] demonstrated that the area of the Medvednica Mountains, situated near neighboring orogens with different subduction polarities, i.e., between the Alps and the Dinarides, has a complex and dual tectonic history. The zone of interference is large; not only do the structures of the Dinarides extend far into the Southern Alps, but the structures of the Eastern and Southern Alps also extend much farther into the Dinarides than previously thought. To show the structural complexity of the Medvednica Mountains, Van Gelder et al. [11] interpreted two cross-sections across the mountain (Figure 1b). The latest tectonic phase of the tectonic evolution of the Medvednica Mountains is characterized by a system of Pliocene to Quaternary southeast-dipping reverse faults (D6 faults in Figure 1b). The Northern Medvednica Boundary Fault [16] is the major fault of the system and is probably still active [8].

Using the previously described methodology, a primary fault plane was modeled (Fault 1) based on the dataset containing 45 hypocenters, including most of the highest magnitude events in the Zagreb 2020 earthquake sequence. The fault is characterized by an orientation similar to the southeast-dipping instrumentally calculated fault-plane solutions of the main shock and the strongest aftershock (Figure 4). The rupture along Fault 1 propagated towards the northwest, apparently along a deep-rooted southeast-dipping thrust fault (125/31, dip direction/dip angle). The thrust fault can be projected to the surface where it virtually appears in the central part of the Hrvatsko Zagorje basin (Figures 1b and 13).

A system of south-dipping longitudinal reverse faults has been mapped on the surface along the Medvednica Mountains [15] and interpreted in one of the latest tectonic models as the youngest (Pliocene to Quaternary) system of reverse faults ([11]; Figure 1) that are probably still active [7]. The reverse slip of the primary ruptured fault (Fault 1) of the Zagreb 2020 earthquake sequence (Figure 13; Supplement 1) generally corresponds to the frontal reverse fault striking along the northern foothills of the mountain (Figure 1b). However, the interpreted steep frontal reverse fault does not match the modeled gently inclined primary fault that is here interpreted as a thrust fault (Figure 13). Thus, a fault that could accommodate such a movement is probably a southeast-dipping thrust fault that completely dissects the basement of the central part of the Medvednica Mountains. This master thrust could represent a basal detachment (décollement) of the system of steeper reverse faults striking along the Medvednica Mountains. It could be steeper in the frontal part and thus could match the North Medvednica reverse fault, or it could be buried below the Neogene Hrvatsko Zagorje basin (Figure 1b; Figures 12 and 13).

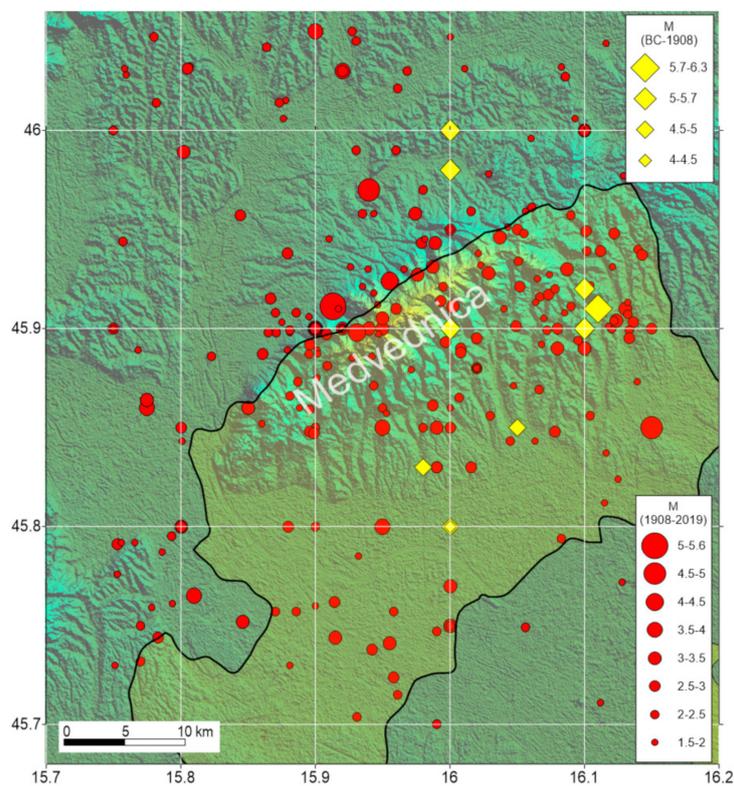
Figure 2. Spatial distribution of earthquakes with locations in the wider Zagreb area from BC to 2019 (according to the updated version of the Croatian Earthquake Catalogue, first described in [18]). The urbanized Zagreb city area is displayed with yellow shadowing.

Figure 2 displays the locations of the epicenters of all earthquakes that have occurred in the wider Zagreb area (BC to 2019).

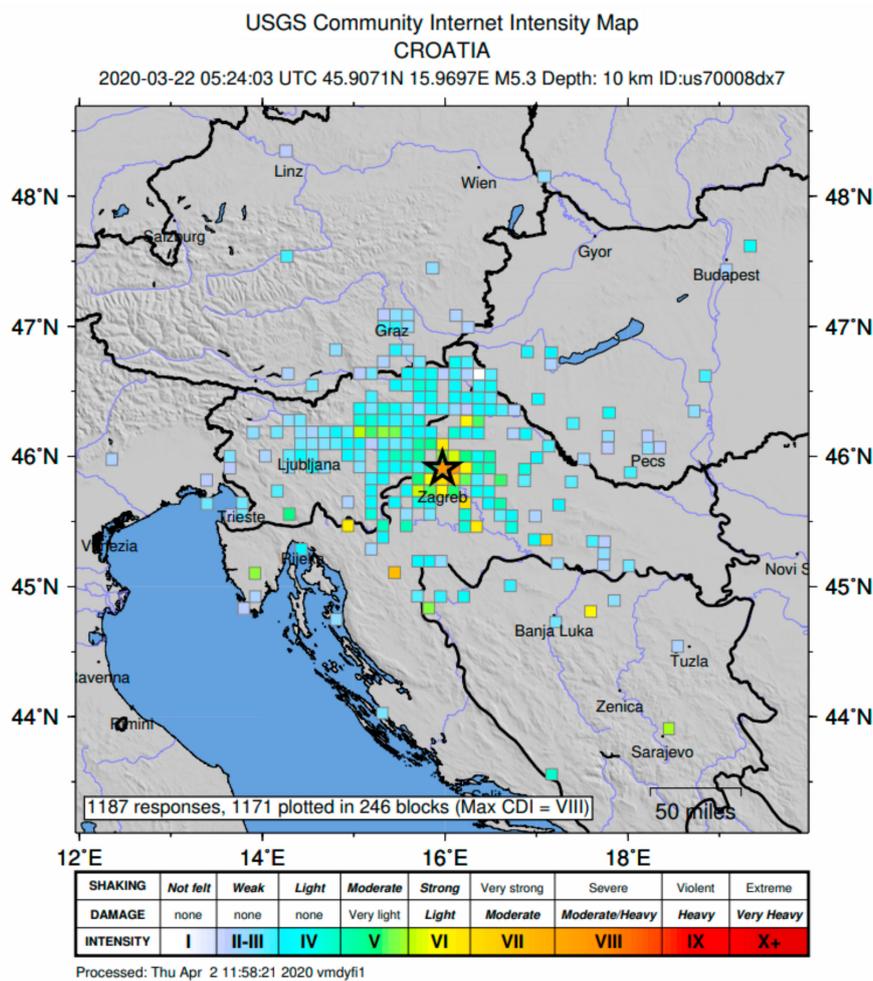
Figure 3. Intensity map according to data collected by USGS [19].

In the early Sunday morning of 22 March 2020, at 05:24 UTC, Zagreb residents were awakened by a strong earthquake. Its epicenter was 7 km north of the center of Zagreb, in the vicinity of Markuševac and Čučerje, and the hypocenter was at a depth of 10 km. In addition, it will be remembered as the strongest earthquake that has happened in the 140 years after the “Great Zagreb earthquake” of 1880. The earthquake was felt with a maximal intensity of VII–VIII °MSK (Figure 3) and had a magnitude (M_L) of 5.5. It was felt all over Croatia, even at a distance of more than 1000 km from the epicenter.

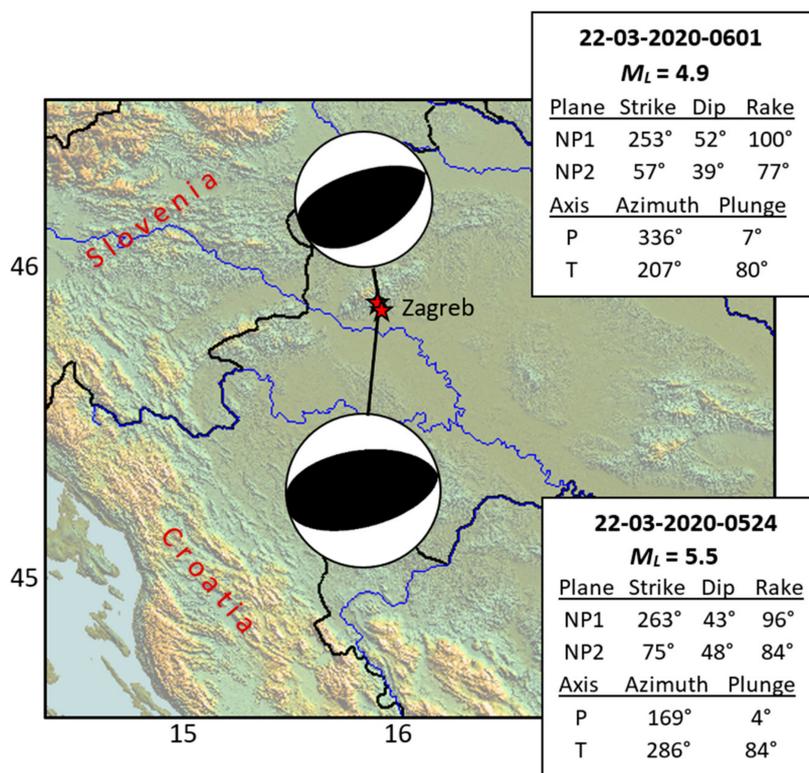
Figure 4. Fault-plane solutions of 22 March 2020 earthquakes at 05:24 UTC and 06:01 UTC. The focal sphere is shown in stereographic projection.

Based on the analysis of data recorded in Croatia and around the world (waveform data taken from the USGS National Earthquake Information Center [20]), the focal mechanisms of the main earthquake and the strongest aftershock were calculated (Figure 4).

The fault-plane solution of the main shock indicates that the earthquake occurred on a reverse fault whose fault plane dips at an angle of 43° to the south-southeast or at an angle of 48° to the north-northwest. The axis of maximum tectonic pressure (P) was horizontal and in the SSE-NNW direction, while the axis of maximum tension (T) was almost vertical. The calculated fault mechanisms will be described in greater detail in Section 4.5 and linked to the geological features of the study area.

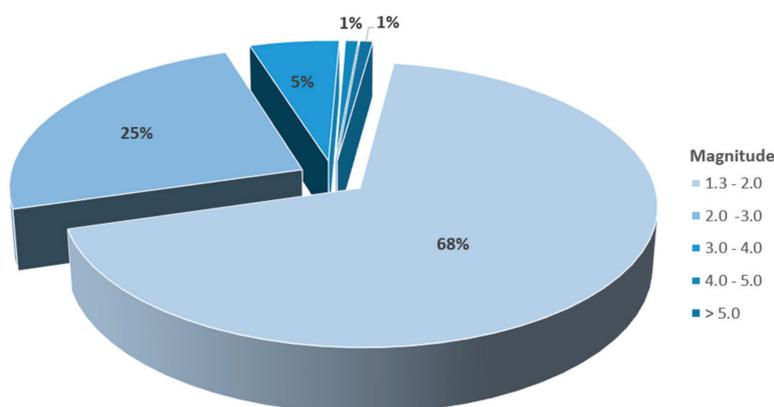
Figure 5. Percentage of earthquakes of each magnitude interval that occurred in the epicentral area of the Zagreb earthquake in the period from 22 March to 1 April 2020.

Since no one knows how much accumulated energy is released through a main earthquake, the aftershock activity is normal and not uncommon. Figure 5 presents the number of earthquakes of a certain magnitude (greater than 1.3) that occurred after the main earthquake of 22 March 2020 at 05:24 UTC.

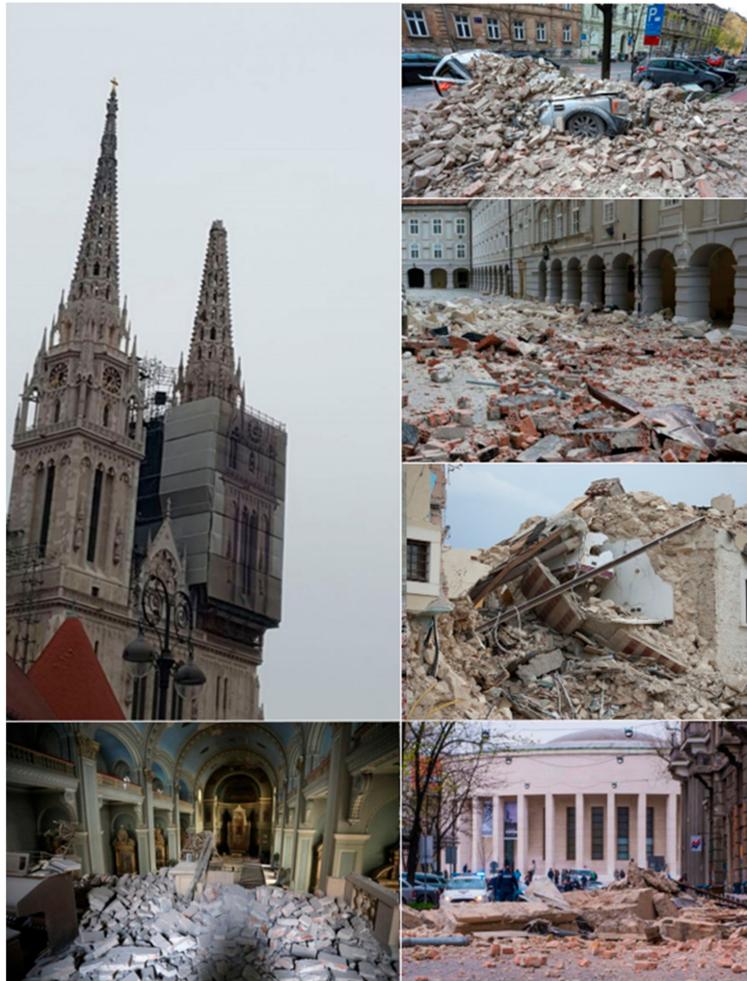
Figure 6. Photos of damage in Zagreb caused by the 22 March 2020 earthquake.

The earthquake hit the city center hardest, and the initial information indicated that the damage was great. Much damage to the cultural and historical architectural heritage of the city of Zagreb was reported, with severe damage to the south tower of Zagreb Cathedral. About 16,555 residential, public and monumental buildings were damaged (Figure 6) as declared by [21,22].

Figure 6 illustrates that in the old city center, three- to five-story masonry buildings, constructed from the time period of the Austro-Hungarian monarchy to 1920, sustained very heavy damage or were destroyed due to the M5.5 Zagreb earthquake on 22 March 2020. There were 26,197 damaged buildings in total (approximately 1900 uninhabitable), among which 9642 were family houses (as declared by [21,22]). As stated in the Disaster Risk Assessment for the Republic of Croatia [24], before 1920, masonry buildings used wooden slab construction, while reinforced concrete (RC) slabs were introduced in the period from 1920 to 1945. Before 1945, buildings possessed only initial earthquake resistance, and earthquake load was not considered in design (up to 5% of relevant peak ground acceleration-PGA was considered in design due to wind load). In compliance with Earthquake Hazard Map of Republic of Croatia [25], the relevant PGA based on 10% exceedance in 50 years, i.e., a return period of 475 years in the Zagreb area goes up to 0.28 g. The consideration of earthquake action in the design of buildings dates from 1946; however, the designs provided inadequate solutions. From 1945 to 1964, earthquake load was considered in the design of buildings by using simplified methodologies (the horizontal force at the top of the building); however, only up to 10% of the relevant PGA was considered in design. In 1964, as a result of the M6.9 Skopje (North Macedonia) earthquake in 1963, the Ordinance on Temporary Technical Regulations for Construction in Seismic Areas (Federal Republic of Yugoslavia (FRY) Official Journal, [26]) was issued. The ordinance required the construction of vertical or horizontal confining elements in masonry buildings, but it provided low earthquake resistance in general. In 1981, it was replaced by the Ordinance on Technical Standards for the Construction of High-Rise Buildings in Seismic Areas (FRY Official Journal, [27]), which provided moderate resistance. Between the years 1964 and 1998, 30–50% of the relevant PGA was considered in the building earthquake resistance design, and 70–100% was considered between 1998 and 2013. The aforementioned regulations were completely replaced by the contemporary standard EN 1998-1 [28] in 2013, which ensured high earthquake resistance (i.e., the earthquake load considered equals 100% of the relevant PGA).

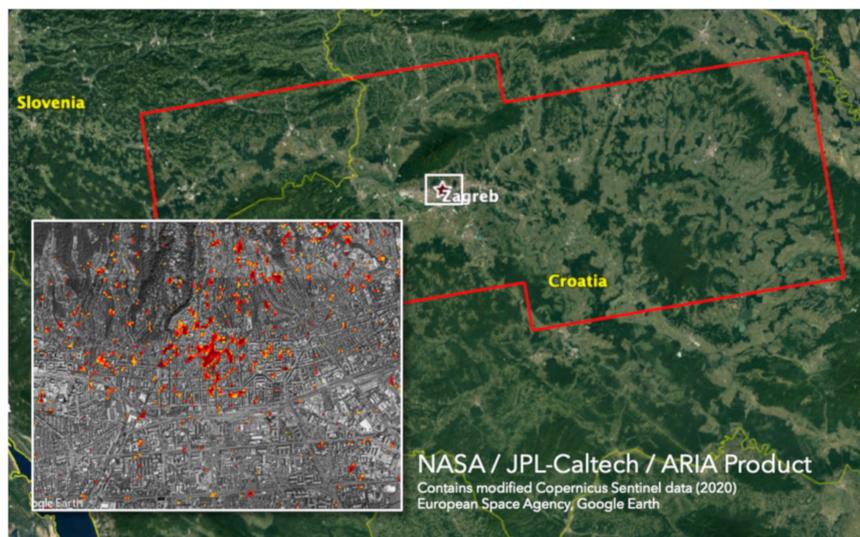
Figure 7. Damage proxy map created by the Advanced Rapid Imaging and Analysis (ARIA) team at NASA's Jet Propulsion Laboratory (JPL) and the California Institute of Technology. This map contains modified Copernicus Sentinel data, processed by the ESA and analyzed by the NASA JPL/Caltech ARIA team. This task was carried out at the JPL, funded by NASA. [23].

The extent of the damage is also visible on the damage proxy map (DPM) (Figure 7), which was created by the Advanced Rapid Imaging and Analysis (ARIA) team at NASA's Jet Propulsion Laboratory and the California Institute of Technology, both in Pasadena, California. The map depicts areas that were likely damaged. The map was derived from synthetic aperture radar (SAR) images from the Copernicus Sentinel-1 satellites, operated by the European Space Agency (ESA). The team compared a post-event image acquired on 23 March 2020 with pre-event images taken since January 2020. The image covers an area of 166 by 56 km (103 by 35 miles), shown by the large red polygon. Each pixel measures approximately 30 m across. The color variations from yellow to red indicate increasingly significant surface changes. Preliminary validation was performed by using photographs from various sources, including news media. This damage proxy map should be used as a guide to identify damaged areas. The full map is available online at [23].

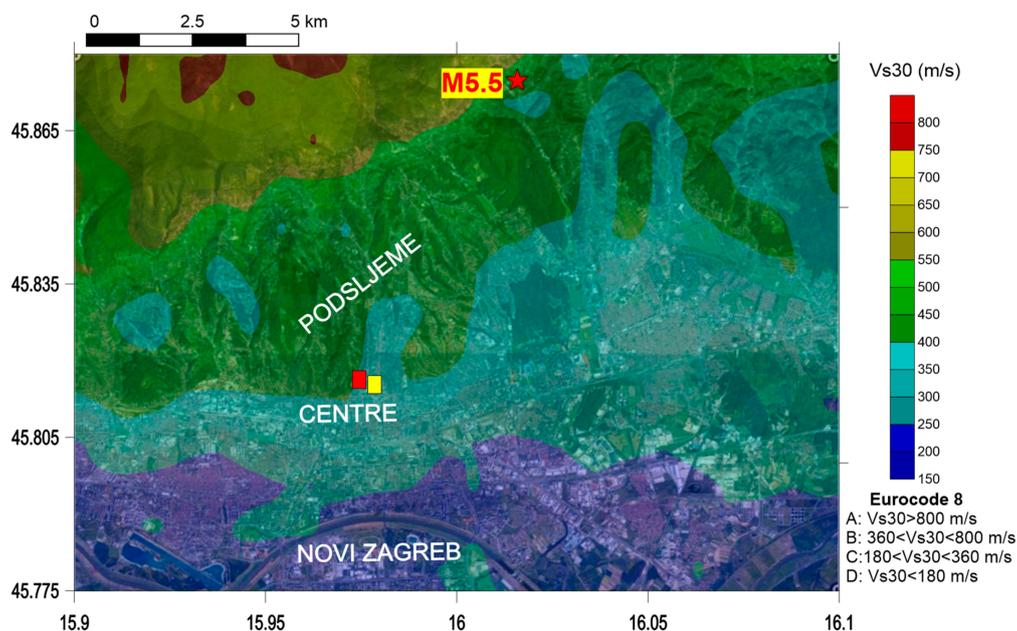
Figure 8. V_{S30} map of the Zagreb area obtained based on approximation via correlation to topographic slope ([46]; source: [47]). Locations of Zagreb Cathedral (yellow square) and Croatian Parliament (red square) are shown. The M5.5 epicenter location is marked with a red star.

Interestingly, the first scientifically explained observation of the local soil amplification effects and variable earthquake damage due to different local geological units during shaking was presented by Stur [44], who analyzed the Klana (Croatia) earthquake sequence with the main shock on 1 March 1870 ($I_{max} = VIII$ °MSK), presenting a detailed report on building construction and observations of the unequal distribution of earthquake damage related to soil conditions with geological sketches, damage locations of objects and a map of the shaken area. Herak et al. [45] presented their macroseismic study of this earthquake sequence and measured the horizontal-to-vertical spectral ratios (HVSRS) of ambient noise at six locations to compare estimates of soil response in the epicentral area with observations of site effects [44] during the Klana earthquake. Presented findings and observations from [45] are similar to the observations of [44] about local site effects in Klana and Studena. Similarly, we attempted to assess the seismic site amplification distribution that occurred during the Zagreb M5.5 earthquake to possibly correlate it with observed damage in the city area and local site effects. For the first-order assessment of seismic site conditions, we used maps of the average shear velocity down to 30 m (V_{S30}), which is correlated with topographic slope [46], as displayed in Figure 8.

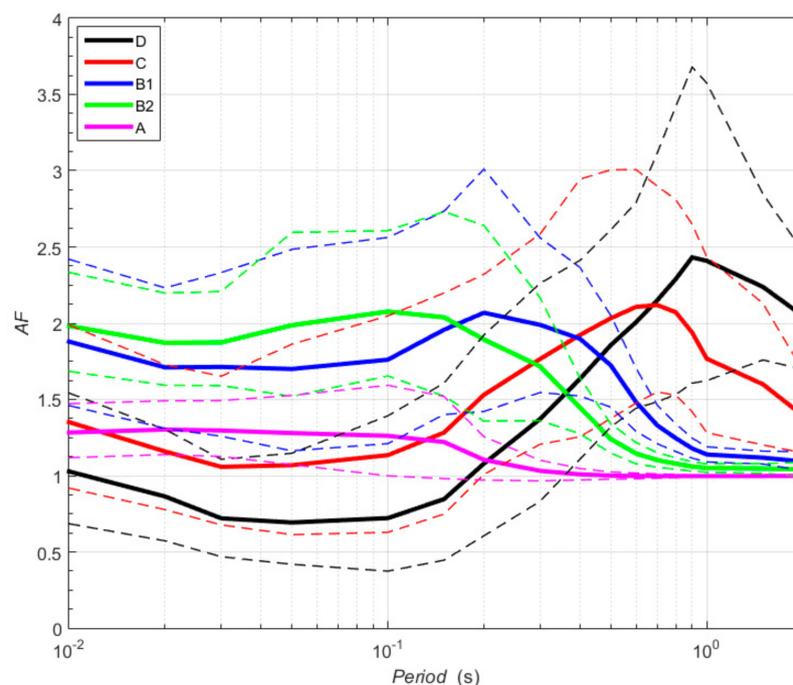
Figure 9. Median site amplification factors [41] for V_{S30} site classes based on Eurocode 8 with (± 1 standard deviation (dashed lines) for the PGA_{ROCK} in the range of 0.159–0.185 g.

the well-known properties of random vibration theory (RVT) and seismological source theory [52], PGA_{ROCK} values for the M5.5 Zagreb earthquake were estimated (from the Fourier amplitude spectrum (FAS)). The input motion in the RVT-based method is typically defined by Brune's [53] omega-squared point-source stochastic model. The stress drop was set to the prescribed constant value of 100 bar (e.g., see [54]), the focal depth was taken as $h = 10$ km, the average value of crustal shear wave velocity was equal to 3.5 km/s and the density was 2800 kg/m³. Frequency-dependent attenuation, the $Q(f)$ value, was adopted from [55] as $Q_c(f) = 78f_c^{0.69}$, and the near-site attenuation parameter $\kappa_0 = 0.028$ s was adopted from [56]. We chose to select locations near epicentral area and set the epicentral distance to vary from 1 to 5 km. The corresponding target values of PGA_{ROCK} were calculated in the range of 0.159–0.185 g. Based on these results, we estimated the median site amplification factor (± 1 standard deviation) using the Stanko et al. [48] model for V_{S30} categories defined by Eurocode 8 (Figure 9). Standard deviation of median site amplification describes site response variability as the effect of variations in ground motions and local site parameters. For site class B, we used two bins, 360–600 m/s (B1) and 600–800 m/s (B2), consistent with the findings of [57]. As underlined in [58], profiles with relatively shallow surface layers underlain by hard bedrock surfaces may have high impedance contrasts leading to strong resonance effects, which is the case for the Zagreb Podsljeme zone. The dominant period/frequency of the ground motion and the natural period/frequency of the soil are especially critical for possible resonance effects during earthquakes, which can result in heavy destruction. Therefore, knowing the building resonance frequency is important for structural stability during earthquakes and for limiting the extent of resonance damage. If the period of ground motion matches the natural resonance of a building, it undergoes the largest oscillations possible and suffers the greatest damage [30]. In general, the Zagreb residential area in terms of V_{S30} categories is in categories B1 (Podsljeme) and C (city center and Novi Zagreb), which show site amplifications most prominent between 0.1–0.5 s (2–10 Hz) and 0.4–0.9 s (1.1–2.5 Hz). Compared to the period–building relationship of $T = 0.016H$ presented in [59], these periods correspond to family houses and 3- to 4-story (B1) and 4- to 15-story buildings (C1).

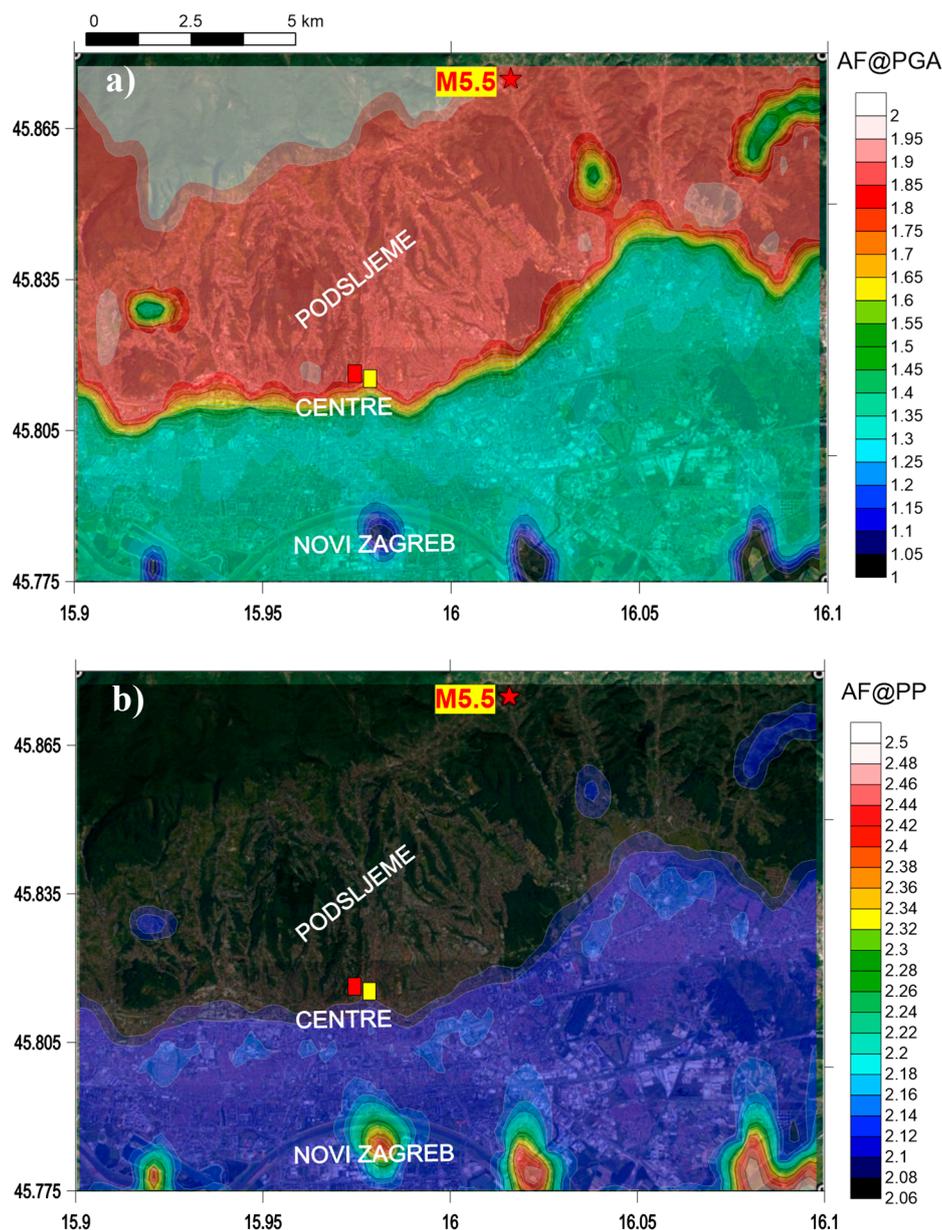
Figure 10. (a) Site amplification map for the PGA at surface ($AF@PGA$) and (b) the predominant amplification peak period ($AF@PP$) for estimated PGA_{ROCK} .

Figure 10 shows two site amplification maps for the PGA at the surface (AF@PGA) and for the predominant amplification peak period (AF@PP) for estimated PGA_{ROCK} . The amplification factor at the surface (AF@PGA) of the input M5.5 event seismic motion (approximately estimated between 0.16–0.19 g) tends to be 1.6–1.8 in the Podsljeme zone, approximately 1.4–1.6 in the city center and approximately 1.3 in the alluvial Sava zone (Novi Zagreb) due to the nonlinear effects of strong shaking [42]. At the resonant period (AF@PP), the observed amplification factor varies from 2.1 in the Podsljeme zone to 2.2 in city center and 2.4 in the Sava alluvial zone. Observed amplifications probably can also be correlated with ground motion polarization and directionality at sites with pronounced topography [60].

The first-order assessment of seismic amplification (due to site conditions) in the Zagreb area for the M5.5 earthquake shows that ground motions of approximately 0.16–0.19 g were amplified at least twice (if the standard deviation is taken into account, they can be amplified by a factor of 3.0 at some locations) in the Podsljeme and city center zones where the greatest extent of the damage is reported. Damage is most prominent in older buildings built before 1964, while newer buildings that were built using Eurocode 8 sustained very little or no damage, particularly in the Novi Zagreb area where the amplification factor at the resonant period is up to 2.4 (with standard deviation, it can be up to 3.6). Severe damage to the south tower of the Zagreb Cathedral (yellow square) could likely be the result of old construction and resonance effects; for category C, AF@PP = 2.2 at the period of 0.8–0.9 s (1.1–1.25 Hz), which corresponds closely to the Cathedral period of 0.71–0.92 s (1.08–1.4 Hz) [61]. Similar results are observed for the Croatian Parliament (also an old building that suffered considerable damage), where the soil category is B1 with estimated AF@PP = 2.08 at a period 0.31 s (3.16 Hz).

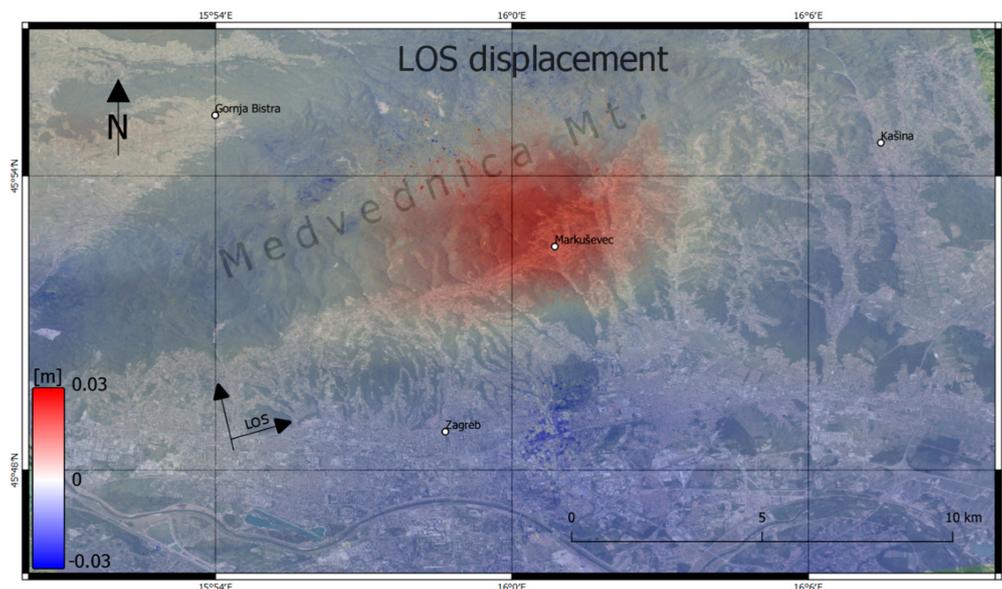
Figure 11. Unwrapped interferogram map indicating co-seismic line-of-sight (LOS) deformation of the 22 March 2020 earthquake.

The observed co-seismic deformation implies an approximately 3 cm uplift of the epicentral area that covers approximately 20 km².

Two Sentinel-1A IW SLC images were processed to derive the co-seismic surface deformation at the Medvednica Mountains (Table 1). Space-borne SAR data are available on the Sentinel data hub [67]. The co-seismic displacement was investigated using differential interferometric synthetic aperture radar (DInSAR) technique [68]. The estimation of earthquake strength was based on the determination of the differential phase angle between two SAR images taken from almost the same satellite position at different times. The differential interferogram was filtered by relevant coherence (>0.2). Interferogram coherence values were moderate on average (0.46), although the affected area is covered with thick vegetation. Time series processing and post-earthquake analysis using radar interferometry were performed with the open-source Sentinel Application Platform (SNAP). Deformation was referenced with the line-of-sight (LOS) direction from radar. The LOS data were acquired by merging different swath phases and then unwrapped using SNAPHU (Statistical-Cost Network-Flow Algorithm for Phase Unwrapping). The results of co-seismic deformation were geocoded to a WGS84 geographic coordinate system (Figure 11). Figure 11 shows an unwrapped interferogram from which it is possible to identify the most affected area.

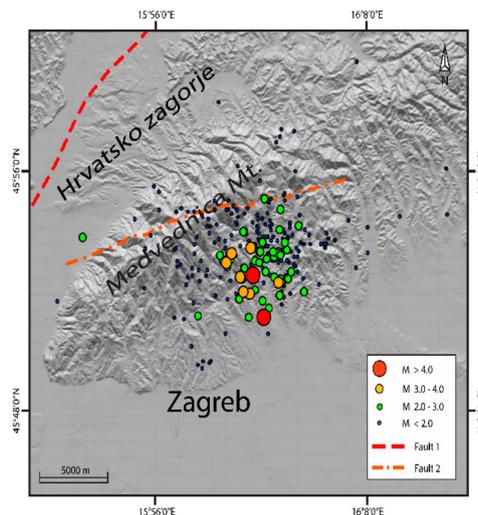
Figure 12. Spatial distribution of earthquake epicenter locations in the period from 22 March to 1 April 2020 (the Zagreb 2020 earthquake sequence). Fault lines are simple projections of the two modeled fault plains from the deep subsurface of the Medvednica Mountains to the surface (see Supplement 1 and Figure 13).

A set of 257 measurements was analyzed both spatially and temporally and processed for import into geological 3D modeling software. To achieve better visual insight, the hypocenters were scaled based on magnitude values (M_L) into four intervals: <2.0, 2.0–3.0, 3.0–4.0 and >4.0 (Figure 12).

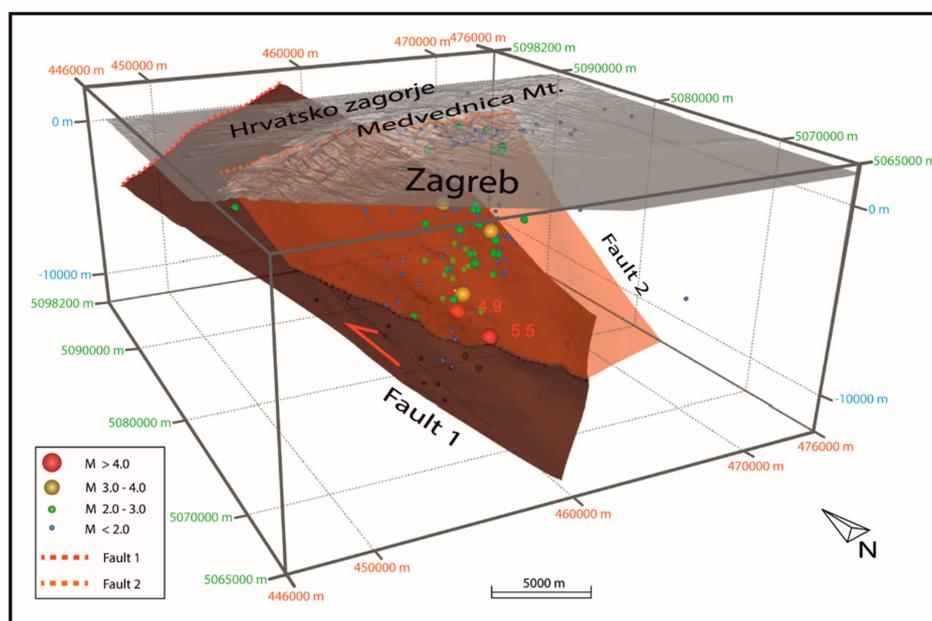
Figure 13. Preliminary structural 3D model of the Zagreb 2020 earthquake sequence. Coordinates are shown in HTRS96/TM coordinate system, and the elevation is in meters (no vertical exaggeration). Fault 1 is interpreted as a primary thrust fault, and Fault 2 is interpreted as a secondary (reverse?) fault.
