The Zagreb (Croatia) M5.5 Earthquake on 22 March 2020

Source / Izvornik: **Geosciences, 2020, 10, - - -**

Article

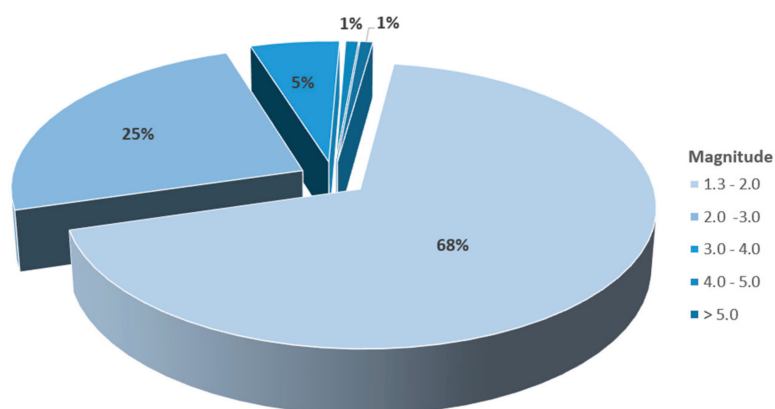
Figure 5. Percentage of earthquakes of each magnitude interval that occurred in the epicentral area of the Zagreb earthquake in the period from 22 March to 1 April 2020.

Since no one knows how much accumulated energy is released through a main earthquake, the aftershock activity is normal and not uncommon. Figure 5 presents the number of earthquakes of a certain magnitude (greater than 1.3) that occurred after the main earthquake of 22 March 2020 at 05:24 UTC.

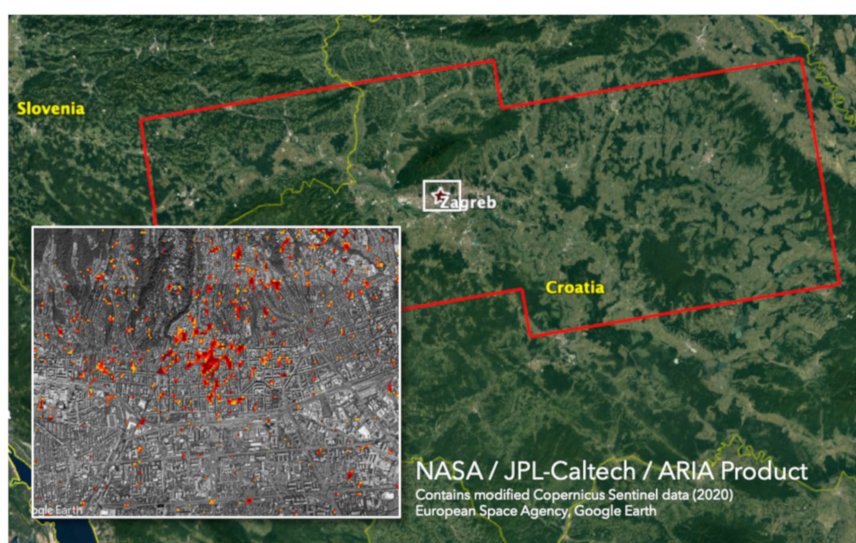
The extent of the damage is also visible on the damage proxy map (DPM) (Figure 7), which was created by the Advanced Rapid Imaging and Analysis (ARIA) team at NASA's Jet Propulsion Laboratory and the California Institute of Technology, both in Pasadena, California. The map depicts areas that were likely damaged. The map was derived from synthetic aperture radar (SAR) images from the Copernicus Sentinel-1 satellites, operated by the European Space Agency (ESA). The team compared a post-event image acquired on 23 March 2020 with pre-event images taken since January 2020. The image covers an area of 166 by 56 km (103 by 35 miles), shown by the large red polygon. Each pixel measures approximately 30 m across. The color variations from yellow to red indicate increasingly significant surface changes. Preliminary validation was performed by using photographs from various sources, including news media. This damage proxy map should be used as a guide to identify damaged areas. The full map is available online at [23].

Figure 7. Damage proxy map created by the Advanced Rapid Imaging and Analysis (ARIA) team at NASA's Jet Propulsion Laboratory (JPL) and the California Institute of Technology. This map contains modified Copernicus Sentinel data, processed by the ESA and analyzed by the NASA JPL/Caltech ARIA team. This task was carried out at the JPL, funded by NASA. [23].

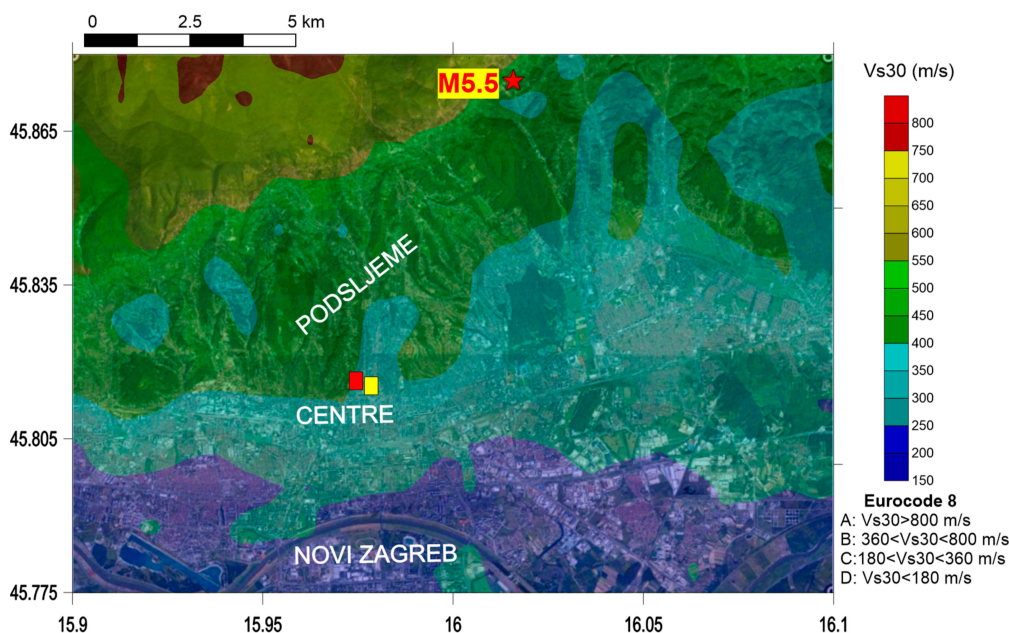
Figure 8. V_{S30} map of the Zagreb area obtained based on approximation via correlation to topographic slope ([46]; source: [47]). Locations of Zagreb Cathedral (yellow square) and Croatian Parliament (red square) are shown. The M5.5 epicenter location is marked with a red star.

Interestingly, the first scientifically explained observation of the local soil amplification effects and variable earthquake damage due to different local geological units during shaking was presented by Stur [44], who analyzed the Klana (Croatia) earthquake sequence with the main shock on 1 March 1870 ($I_{max} = VIII$ °MSK), presenting a detailed report on building construction and observations of the unequal distribution of earthquake damage related to soil conditions with geological sketches, damage locations of objects and a map of the shaken area. Herak et al. [45] presented their macroseismic study of this earthquake sequence and measured the horizontal-to-vertical spectral ratios (HVSRS) of ambient noise at six locations to compare estimates of soil response in the epicentral area with observations of site effects [44] during the Klana earthquake. Presented findings and observations from [45] are similar to the observations of [44] about local site effects in Klana and Studena. Similarly, we attempted to assess the seismic site amplification distribution that occurred during the Zagreb M5.5 earthquake to possibly correlate it with observed damage in the city area and local site effects. For the first-order assessment of seismic site conditions, we used maps of the average shear velocity down to 30 m (V_{S30}), which is correlated with topographic slope [46], as displayed in Figure 8.
