The Zagreb (Croatia) M5.5 Earthquake on 22 March 2020

Keywords: Zagreb earthquake; Medvednica Mountains; seismicity; amplification; structural modeling; building damage

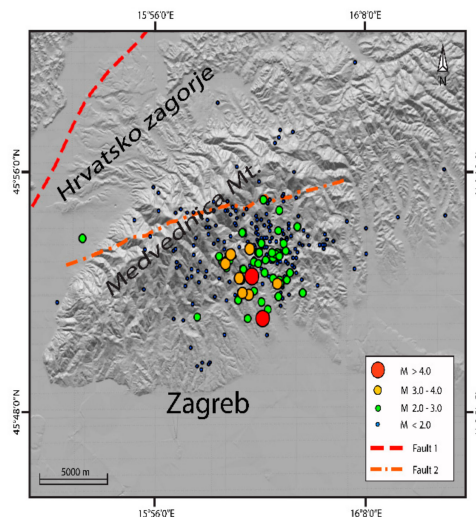
Figure 12. Spatial distribution of earthquake epicenter locations in the period from 22 March to 1 April 2020 (the Zagreb 2020 earthquake sequence). Fault lines are simple projections of the two modeled fault plains from the deep subsurface of the Medvednica Mountains to the surface (see Supplement 1 and Figure 13).

A set of 257 measurements was analyzed both spatially and temporally and processed for import into geological 3D modeling software. To achieve better visual insight, the hypocenters were scaled based on magnitude values (M_L) into four intervals: <2.0, 2.0–3.0, 3.0–4.0 and >4.0 (Figure 12).
