# The Zagreb (Croatia) M5.5 Earthquake on 22 March 2020

**Journal article, Published version**

**Keywords:** Zagreb earthquake; Medvednica Mountains; seismicity; amplification; structural modeling; building damage

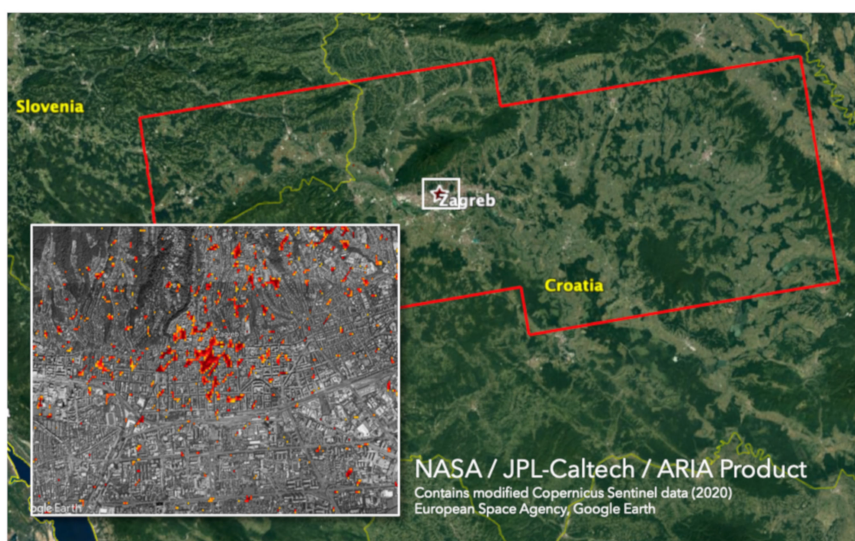
The extent of the damage is also visible on the damage proxy map (DPM) (Figure 7), which was created by the Advanced Rapid Imaging and Analysis (ARIA) team at NASA's Jet Propulsion Laboratory and the California Institute of Technology, both in Pasadena, California. The map depicts areas that were likely damaged. The map was derived from synthetic aperture radar (SAR) images from the Copernicus Sentinel-1 satellites, operated by the European Space Agency (ESA). The team compared a post-event image acquired on 23 March 2020 with pre-event images taken since January 2020. The image covers an area of 166 by 56 km (103 by 35 miles), shown by the large red polygon. Each pixel measures approximately 30 m across. The color variations from yellow to red indicate increasingly significant surface changes. Preliminary validation was performed by using photographs from various sources, including news media. This damage proxy map should be used as a guide to identify damaged areas. The full map is available online at [23].

**Figure 7.** Damage proxy map created by the Advanced Rapid Imaging and Analysis (ARIA) team at NASA's Jet Propulsion Laboratory (JPL) and the California Institute of Technology. This map contains modified Copernicus Sentinel data, processed by the ESA and analyzed by the NASA JPL/Caltech ARIA team. This task was carried out at the JPL, funded by NASA. [23].

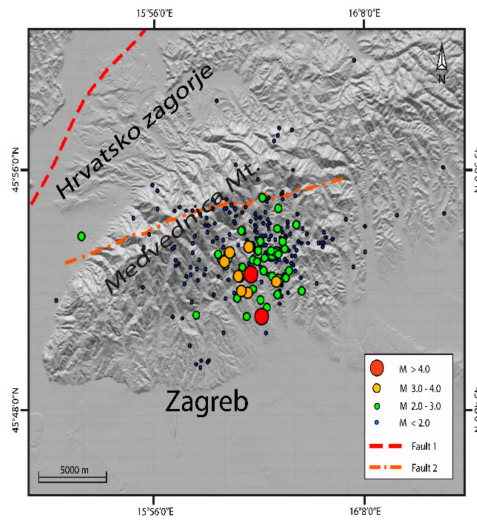
**Figure 12.** Spatial distribution of earthquake epicenter locations in the period from 22 March to 1 April 2020 (the Zagreb 2020 earthquake sequence). Fault lines are simple projections of the two modeled fault plains from the deep subsurface of the Medvednica Mountains to the surface (see Supplement 1 and Figure 13).

A set of 257 measurements was analyzed both spatially and temporally and processed for import into geological 3D modeling software. To achieve better visual insight, the hypocenters were scaled based on magnitude values ( $M_L$ ) into four intervals: <2.0, 2.0–3.0, 3.0–4.0 and >4.0 (Figure 12).

A system of south-dipping longitudinal reverse faults has been mapped on the surface along the Medvednica Mountains [15] and interpreted in one of the latest tectonic models as the youngest (Pliocene to Quaternary) system of reverse faults ([11]; Figure 1) that are probably still active [7]. The reverse slip of the primary ruptured fault (Fault 1) of the Zagreb 2020 earthquake sequence (Figure 13; Supplement 1) generally corresponds to the frontal reverse fault striking along the northern foothills of the mountain (Figure 1b). However, the interpreted steep frontal reverse fault does not match the modeled gently inclined primary fault that is here interpreted as a thrust fault (Figure 13). Thus, a fault that could accommodate such a movement is probably a southeast-dipping thrust fault that completely dissects the basement of the central part of the Medvednica Mountains. This master thrust could represent a basal detachment (décollement) of the system of steeper reverse faults striking along the Medvednica Mountains. It could be steeper in the frontal part and thus could match the North Medvednica reverse fault, or it could be buried below the Neogene Hrvatsko Zagorje basin (Figure 1b; Figures 12 and 13).
