The Zagreb (Croatia) M5.5 Earthquake on 22 March 2020

Markušić, Snježana; Stanko, Davor; Korbar, Tvrtko; Belić, Nikola; Penava, Davorin; Kordić, Branko

Journal article, Published version

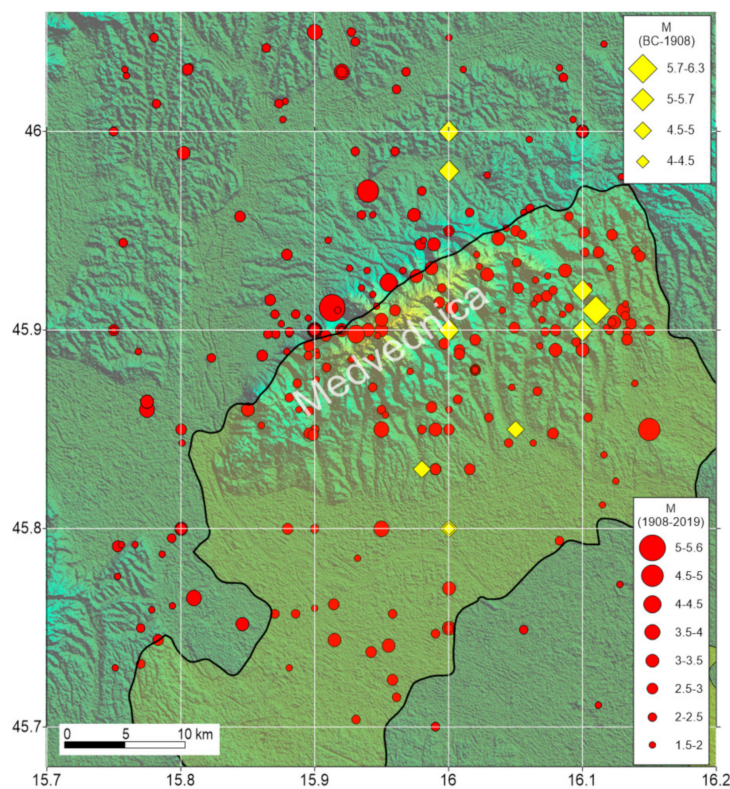
Figure 2. Spatial distribution of earthquakes with locations in the wider Zagreb area from BC to 2019 (according to the updated version of the Croatian Earthquake Catalogue, first described in [18]). The urbanized Zagreb city area is displayed with yellow shadowing.

Figure 2 displays the locations of the epicenters of all earthquakes that have occurred in the wider Zagreb area (BC to 2019).
