The Zagreb (Croatia) M5.5 Earthquake on 22 March 2020

Abstract: On 22 March 2020, Zagreb was struck by an M5.5 earthquake that had been expected for more than 100 years and revealed all the failures in the construction of residential buildings in the Croatian capital, especially those built in the first half of the 20th century. Because of that, extensive seismological, geological, geodetic and structural engineering surveys were conducted immediately after the main shock. This study provides descriptions of damage, specifying the building performances and their correlation with the local soil characteristics, i.e., seismic motion amplification. Co-seismic vertical ground displacement was estimated, and the most affected area is identified according to Sentinel-1 interferometric wide-swath data. Finally, preliminary 3D structural modeling of the earthquake sequence was performed, and two major faults were modeled using inverse distance weight (IDW) interpolation of the grouped hypocenters. The first-order assessment of seismic amplification (due to site conditions) in the Zagreb area for the M5.5 earthquake shows that ground motions of approximately 0.16–0.19 g were amplified at l

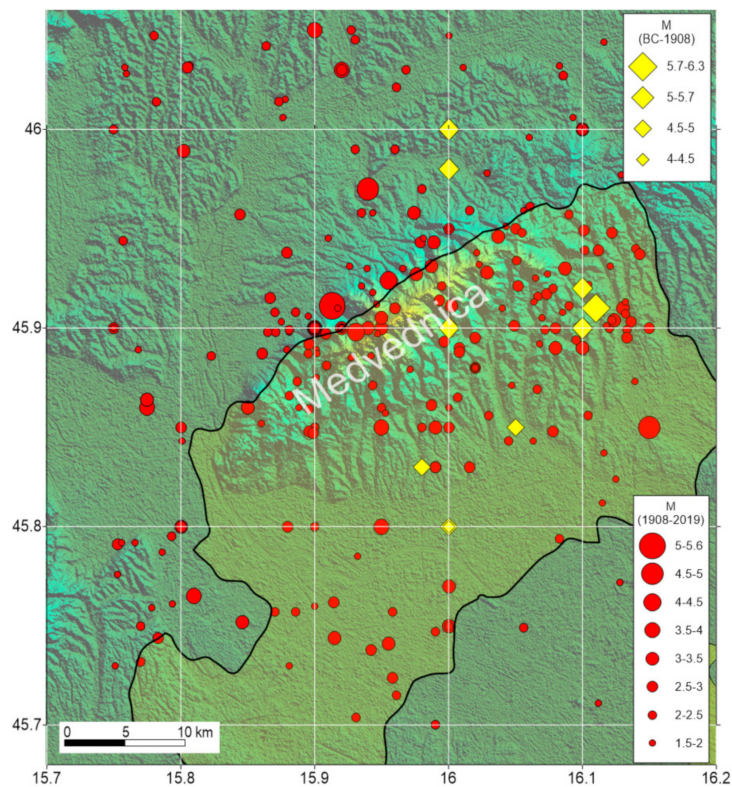
Figure 2. Spatial distribution of earthquakes with locations in the wider Zagreb area from BC to 2019 (according to the updated version of the Croatian Earthquake Catalogue, first described in [18]). The urbanized Zagreb city area is displayed with yellow shadowing.

Figure 2 displays the locations of the epicenters of all earthquakes that have occurred in the wider Zagreb area (BC to 2019).

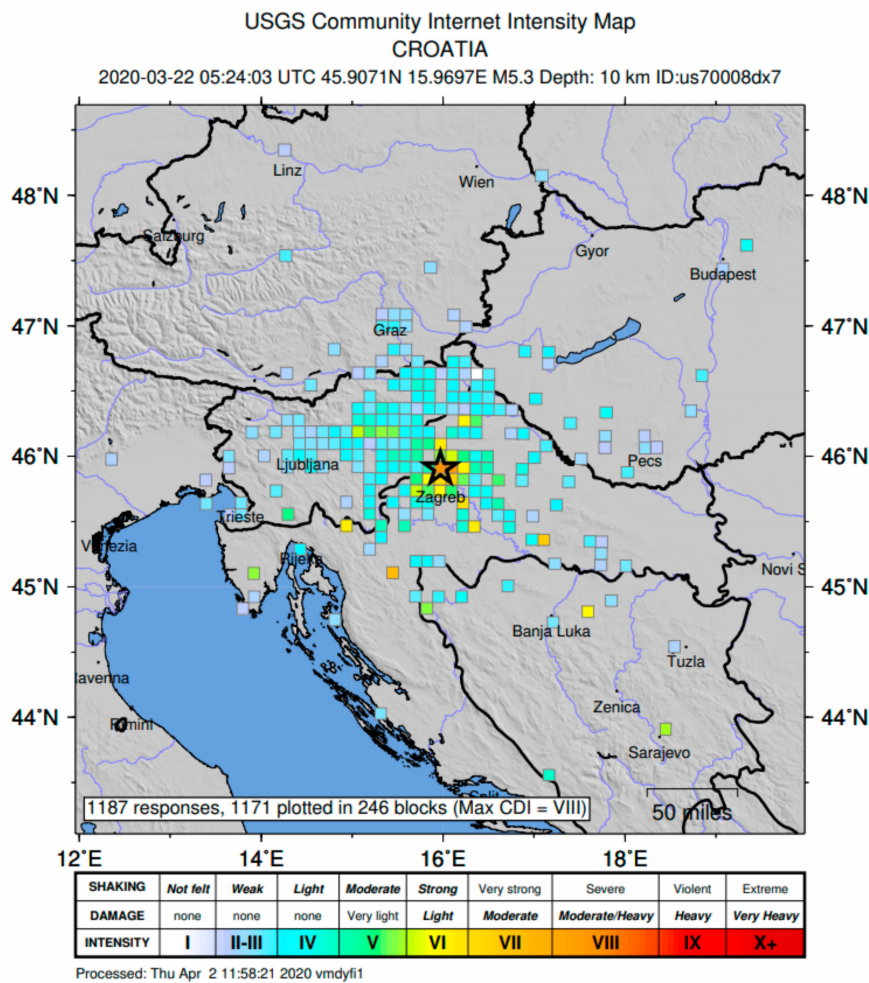
Figure 3. Intensity map according to data collected by USGS [19].

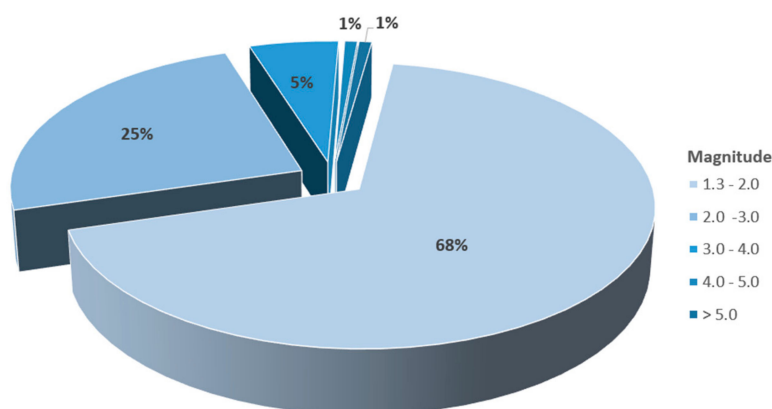
Figure 5. Percentage of earthquakes of each magnitude interval that occurred in the epicentral area of the Zagreb earthquake in the period from 22 March to 1 April 2020.

Since no one knows how much accumulated energy is released through a main earthquake, the aftershock activity is normal and not uncommon. Figure 5 presents the number of earthquakes of a certain magnitude (greater than 1.3) that occurred after the main earthquake of 22 March 2020 at 05:24 UTC.
